AL KUT TRAINING ACADEMY
AL KUT, IRAQ

SIGIR PA-06-069
OCTOBER 18, 2006

SUBJECT: Report on Project Assessment of the Al Kut Training Academy,
Al Kut, Iraq (Report Number SIGIR-PA-06-069)

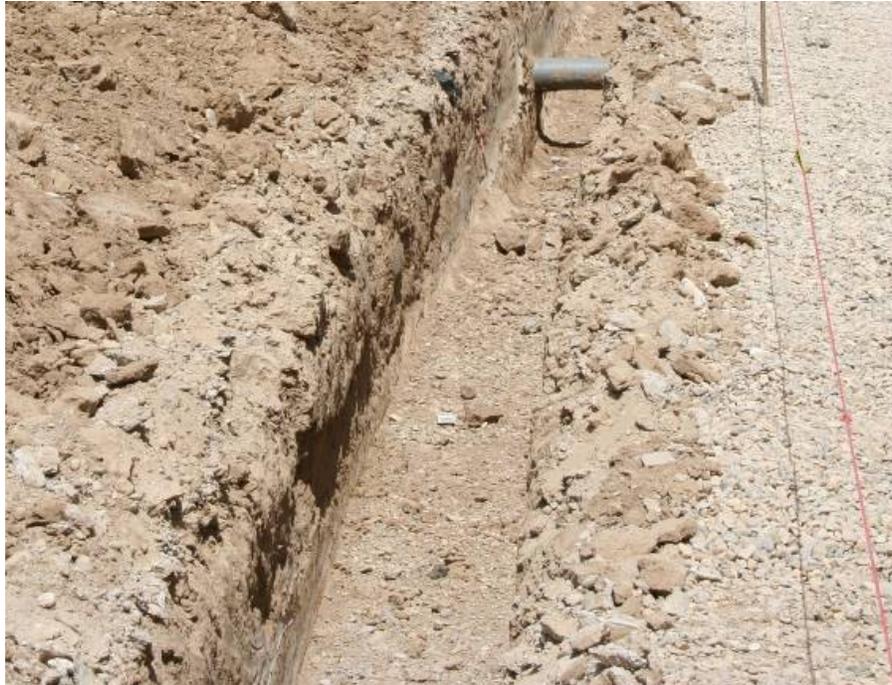
The contractor's original design was a simple septic system comprised of three main tanks. Based on the SIGIR engineer's calculations and a review of the contractor's design, the septic tank capacity varied significantly from actual requirements. In short, the septic tanks installed were substantially undersized. As the population of the academy increased during the early stages of facility operation, the unexpected waste volume and on-site drainage limitations spawned a serious problem. The soil proved to be hard with little drainage capacity and the contractor's design for the septic tank systems did not call for drain fields. During the assessment, the contractor's Program Manager confirmed that a perc test (percolation test) to determine the soil absorption rate for a septic drain field or "leach field" was never conducted. Site Photo 9 shows the nonporous soil.

Site Photo 9. Machine polished trench sidewall soil.

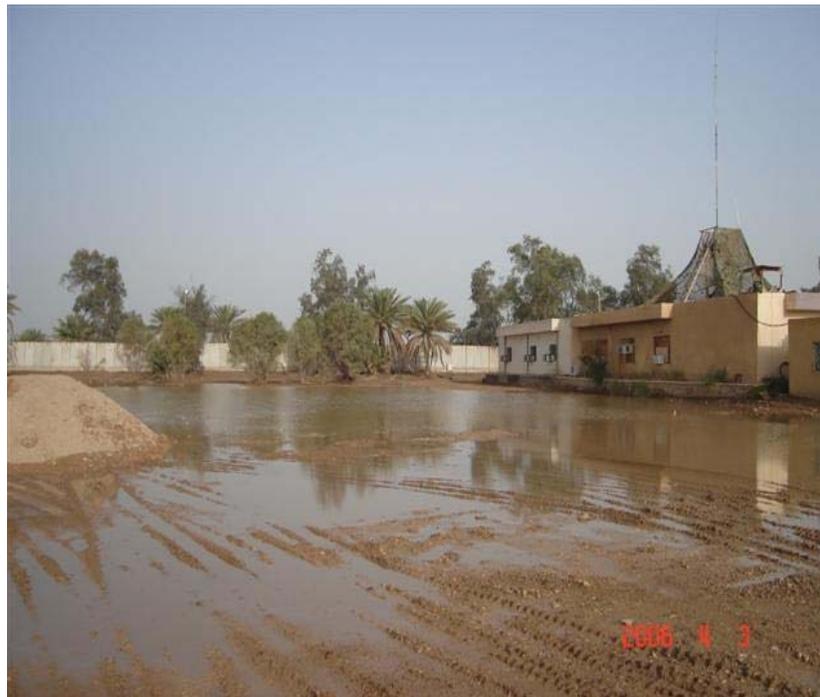
Rather than utilizing a drain field system, the permeable septic tanks were designed to depend on pump trucks to remove excess effluent. However, the contractor's design did not meet requirement because it did not support academy needs in terms of daily volume. When coupled with insufficient soil drainage and limited pump truck capacity, substantial excess waste water overflowed from the septic system. Site Photo 10 shows waste water overflow standing on academy grounds.

Site Photo 10. Standing waste water (Photo courtesy of ECCI).

To alleviate the problem over the long term, a SOW modification pending at the time of our site visit called for a buried pressure line connecting the three separate septic tanks in order to pump the effluent underground to the “Dead River”. While original septic tank sizing and placement did not accurately account for soil conditions or daily volume input, the pending SOW, as modified, will alleviate the overflow problem.

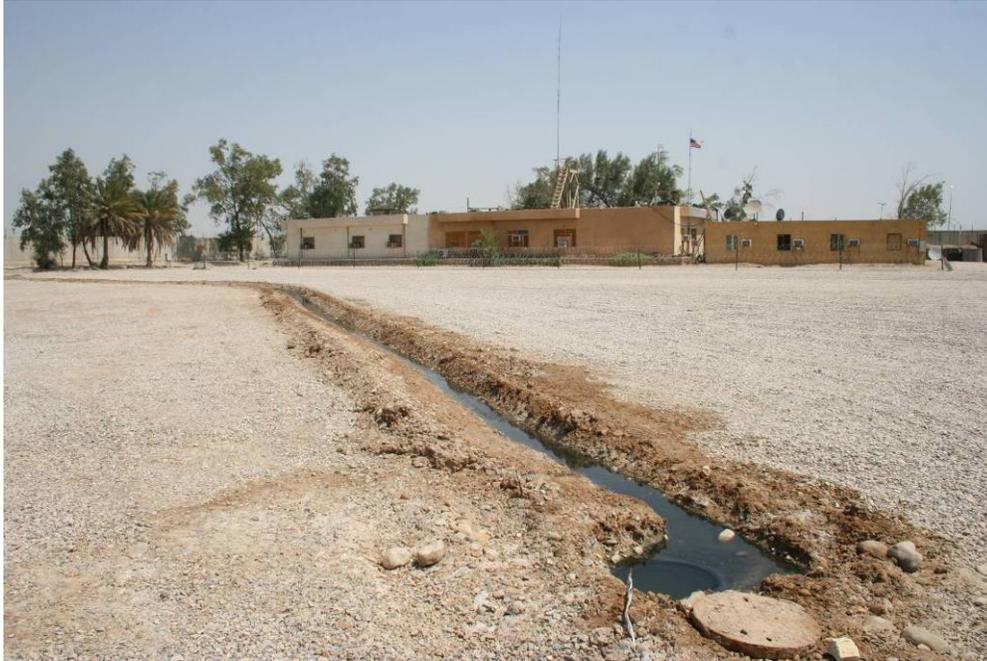
The site assessment disclosed that the main source of the waste water overflow was a septic tank manhole. As a temporary solution to the standing waste water problem, the contractor excavated a surface ditch to drain overflow from the manhole source through the facility to a storm water drainage ditch which empties into a nearby reed filled canal referred to as the “Dead River”. The overflow drainage ditch is shown in Site Photo 11.

Site Photo 11. Surface ditch moving waste water from septic tank manhole to “Dead River”.

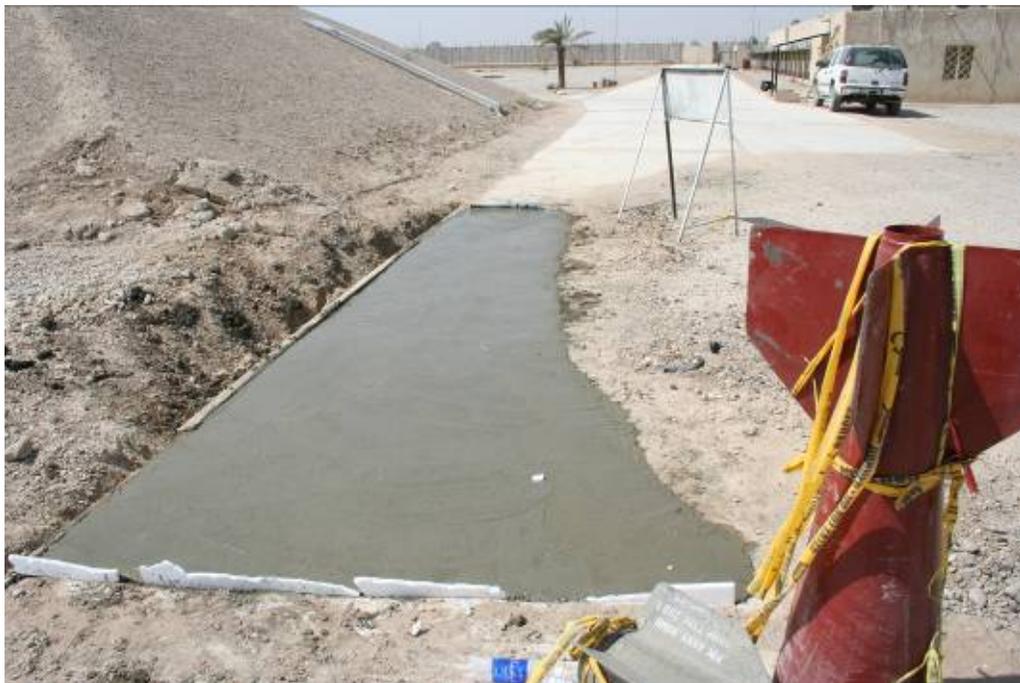
While on site, the assessment team observed that a section of roadway was poured with no hydration until much later in the day. July afternoon temperatures at Al Kut often exceed 110 degrees Fahrenheit. In addition, the team observed that the concrete was not cast to the full thickness of the roadway along the long edge of the casting. Rather, the fresh concrete was layered unevenly over the existing roadway. Site Photo 18 shows the casting just described. Several meters away on the same road, a SIGIR Inspector easily pulled up several pieces of cured cement by hand, without the aid of a tool. The concrete aggregate appeared too large and likely was mixed with an insufficient quantity of water, resulting in concrete that was weak and crumbly. Site Photo 19 shows a piece of concrete removed by hand while Site Photo 20 shows the crumbly nature of the roadway.

Site Photo 18. DBE area roadway.

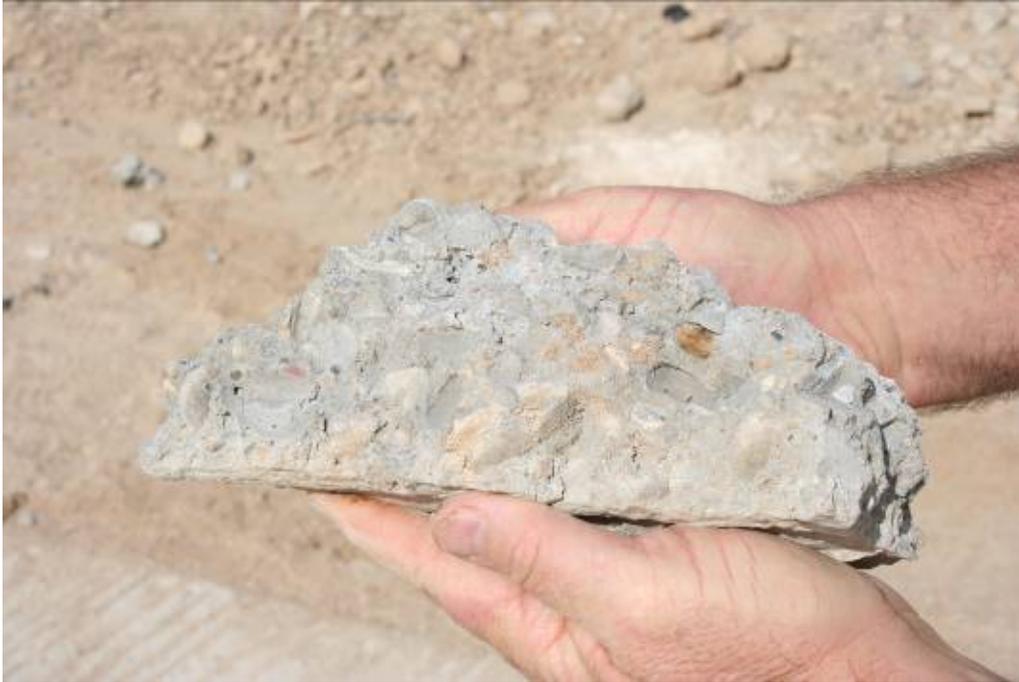
Site Photo 19. Concrete piece pulled from roadway by hand.

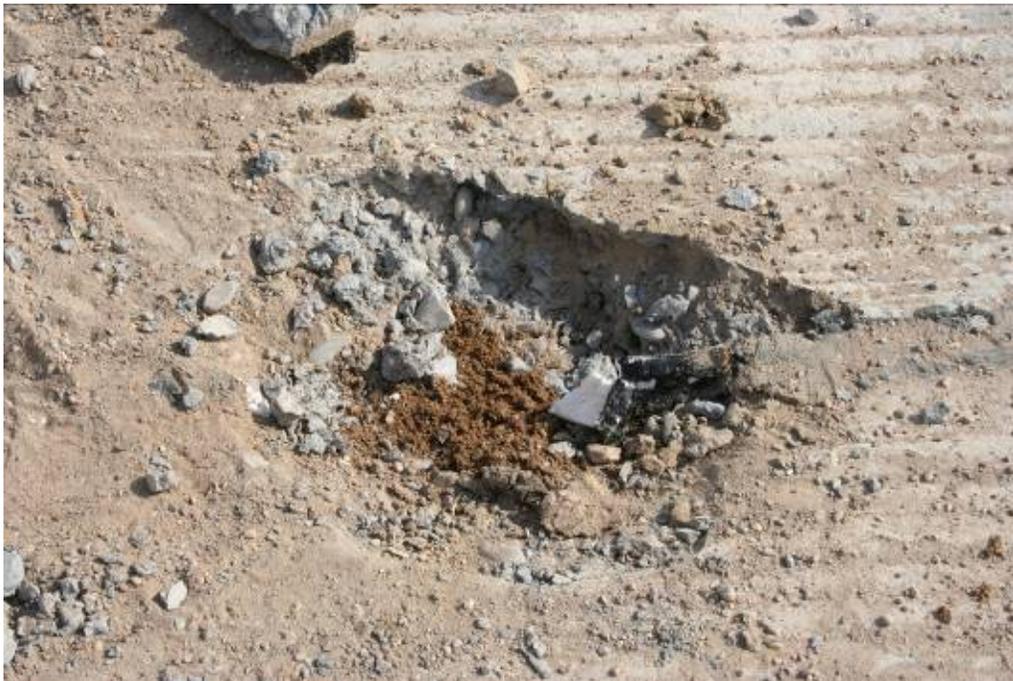
Site Photo 20. Roadway where piece was removed.

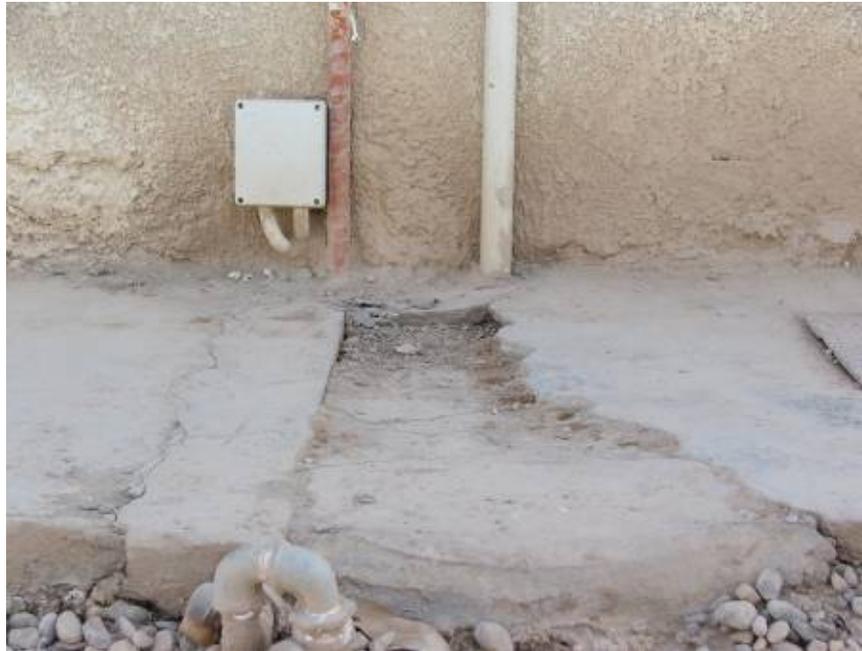
Patchwork installations should conform to applicable flatwork standards in terms of materials and workmanship. The team observed numerous examples of concrete patchwork that was either too thin or placed unevenly and not to code. Site Photo 21 shows an example of such work.

Site Photo 21. Uneven patchwork in Academy HQ sidewalk.

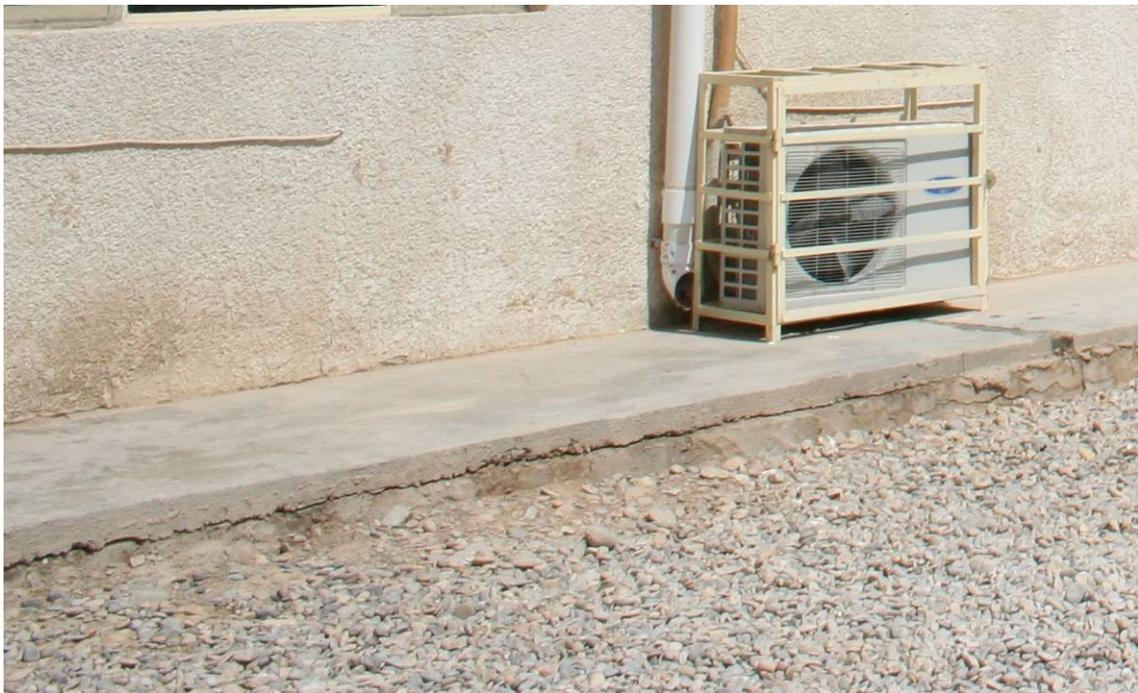
During the site visit, the team observed horizontal fractures that ran along almost the entire perimeter of the newly constructed middle and eastern barracks building foundations. Site Photos 22 and 23 show the described fractures. In addition, similar, but less obvious, horizontal fissures were observed on the second floors of the dormitories.

Site Photo 22. Horizontal fracturing along foundation of middle barracks.

During the assessment, the team was told by the contractor's Project Manager that concrete placement was conducted using small batches mixed by hand. Small hand batch mixing and improper joining techniques could have contributed to the horizontal fractures due to lack of consistency between the numerous small batches mixed by hand. For practicality reasons, each small batch was not subjected to a slump test.

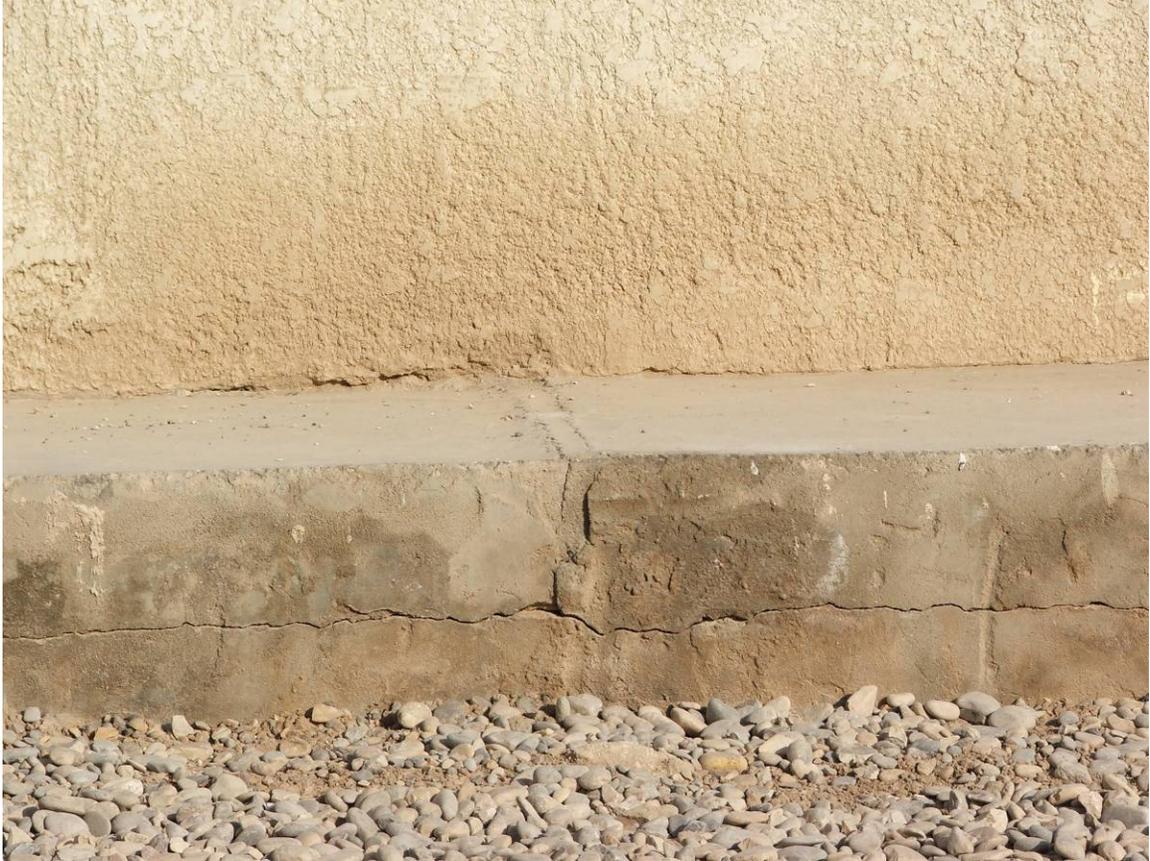
Site Photo 23. East barracks horizontal foundation fracture.

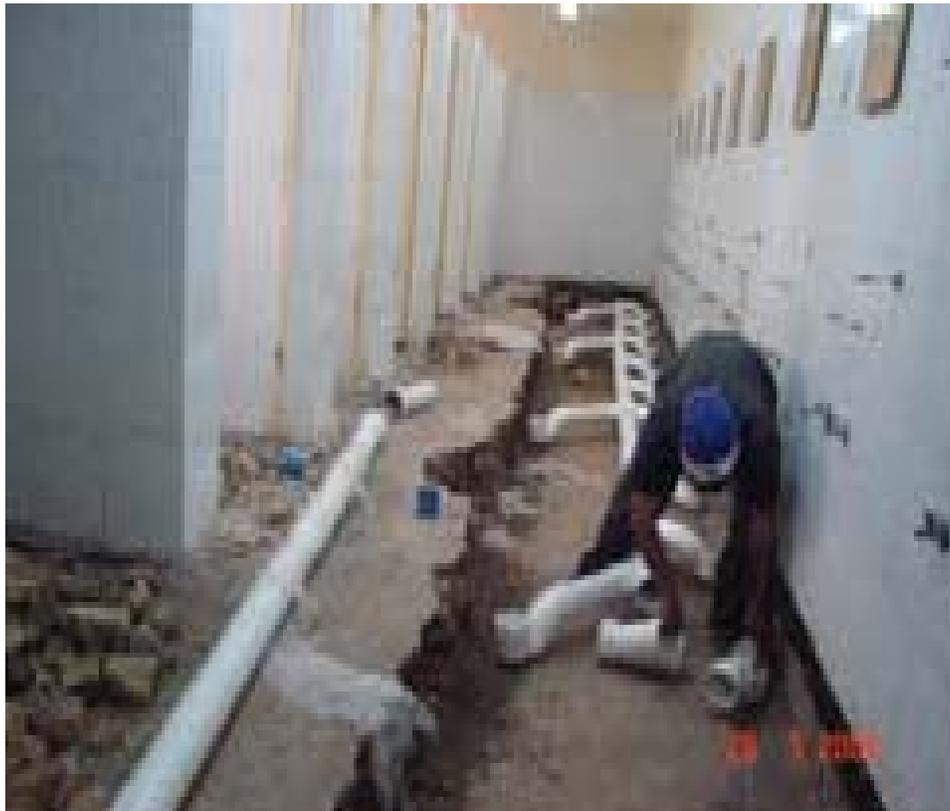
As a result, routine construction deficiencies not detected and corrected as they occurred turned into much larger rework issues. For example, dormitory building D-1 was accepted via DD Form 1354 dated 31 August 2005. However, extensive rework was required within the bathroom to correct the defective construction that should have been detected, monitored, and corrected during construction (Site Photo 24). Specifically, the connections between the smaller diameter feeder drain lines and the larger diameter main drain line system were not water tight because positive connection (glued or threaded) reducers and fittings were not used until the deficiency was corrected in March 2006 (Site Photo 25).

Site Photo 24. Extensive rework in progress (Photo courtesy of ECC).

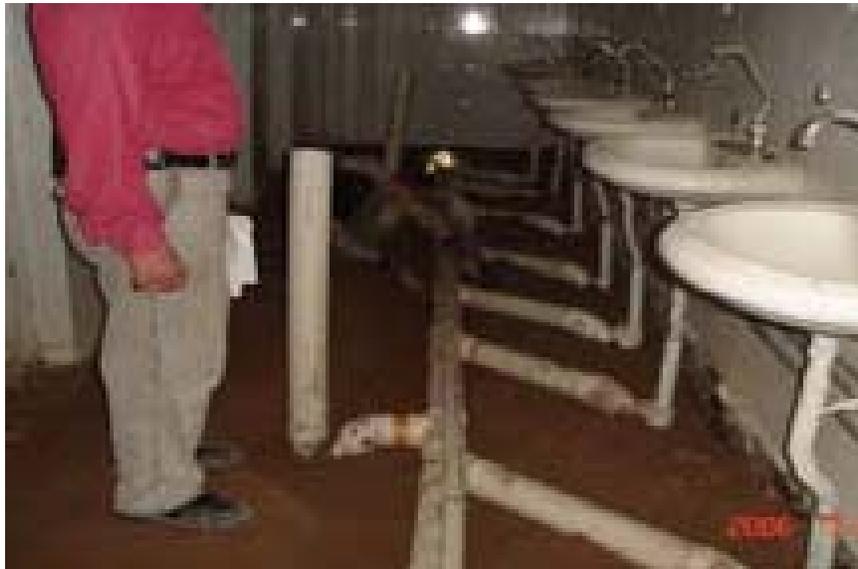
Site Photo 25. Reducers and fittings, before rework, were not water tight (Photo courtesy of ECC).

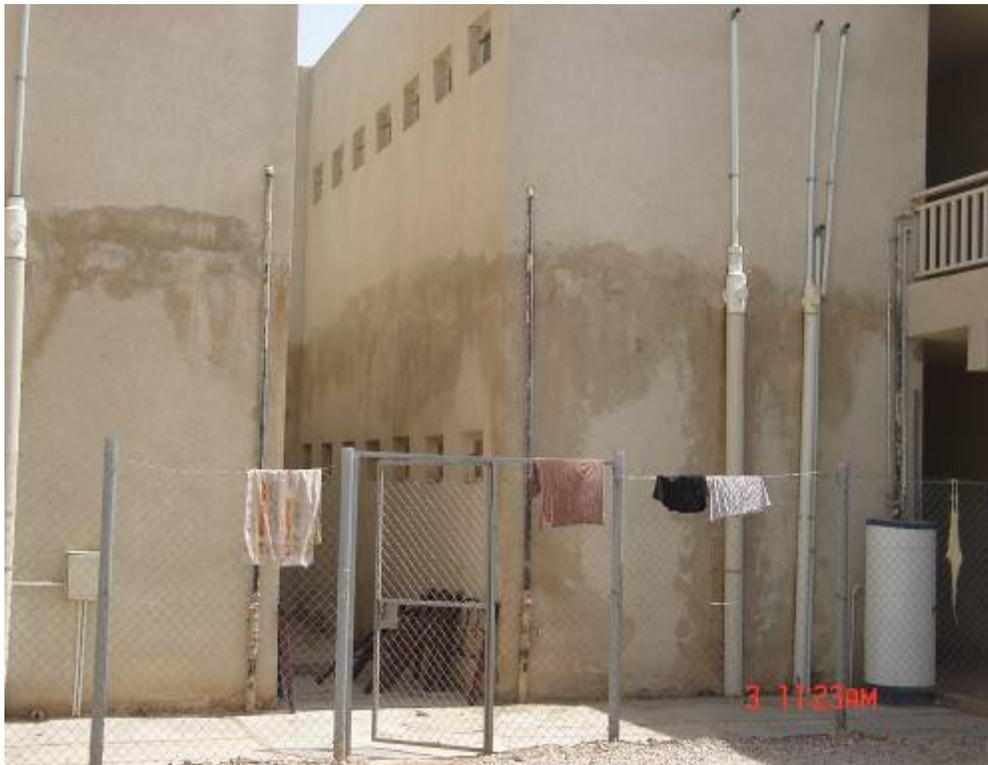
In another very similar example, dormitory building D-4 was accepted via DD1354 on 9 December 2005, but a serious plumbing leak was not reported by QA personnel until 20 April 2006. A photo taken by the government representative on 20 April 2006 shows that substantial water volume migrated subsurface within the second story floor to the outside walls of the building (Site Photo 26).

Site Photo 26. Water stains from improper plumbing (Photo courtesy of ECC).

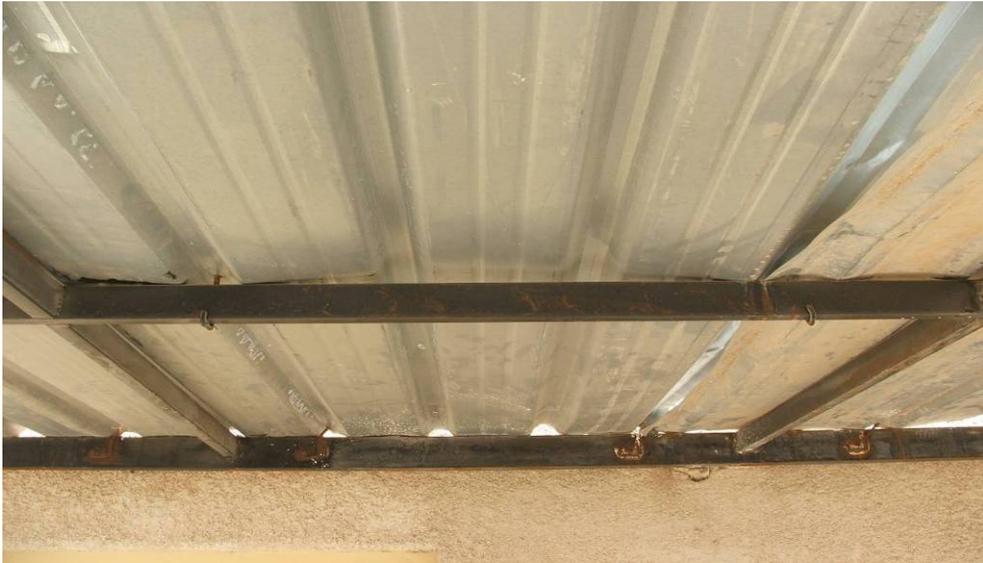
Comparisons of acceptable and not acceptable workmanship for the same task demonstrate the impact of inadequate QM oversight. In the first comparison, the metal roof cover material (Site Photo 27) fastened with too few and improperly located hooks/fasteners to secure the roof cover was compared to properly fastened tin (Site Photo 28) where a fastener was located at tangent points between the tin and the angle iron frame. The second comparison shows water damage to a plywood door improperly hung too close to a wet floor area in a bathroom (Site Photo 29) compared to a door in an adjacent stall properly hung approximately 1” above the floor (Site Photo 30).

Site Photo 27. Tin fastened without sufficient number of fasteners.

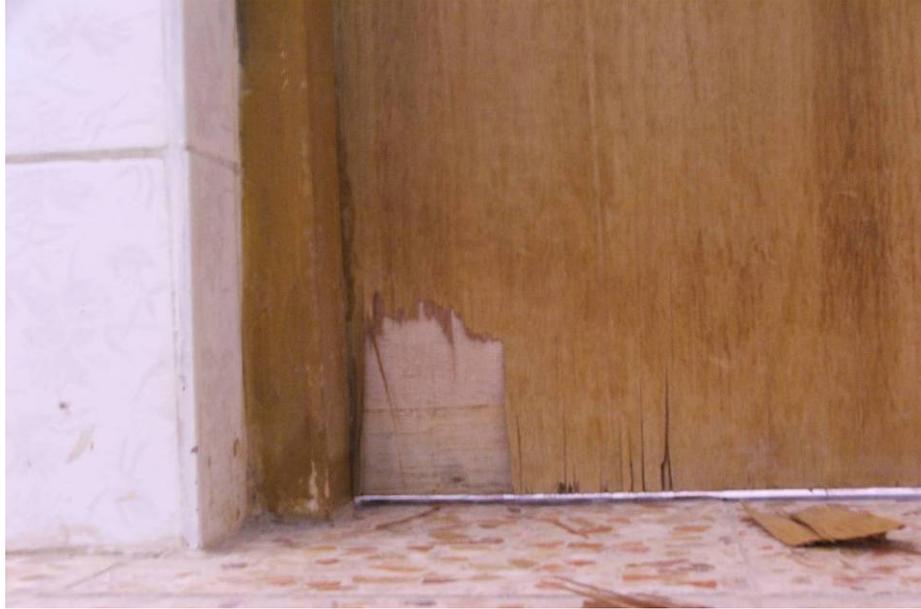
Site Photo 29. Water damaged door installed too close to the floor.

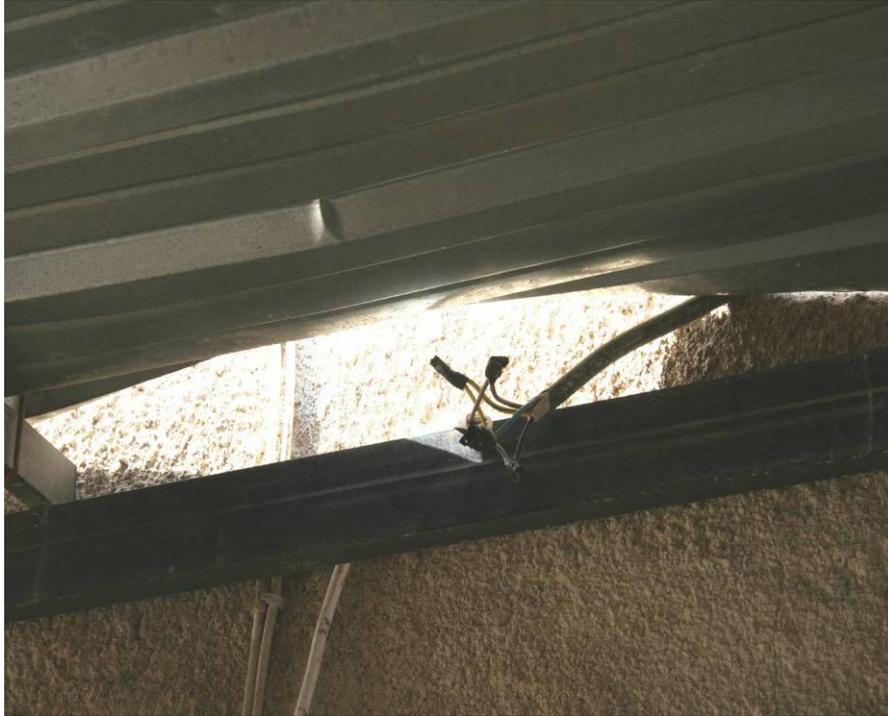
The assessment team observed numerous examples of installations not meeting standards, which if not corrected could lead to significant safety issues. For example, an electric wire splice (Site Photo 31) should have been enclosed in a weather proof box to comply with required codes. In addition, an electric breaker box installed on an exterior wall not sealed from the weather (Site Photo 32) could short-circuit and start a fire or cause serious injury.

Site Photo 31. Unsafe electric wire splice not secured in an enclosed box.

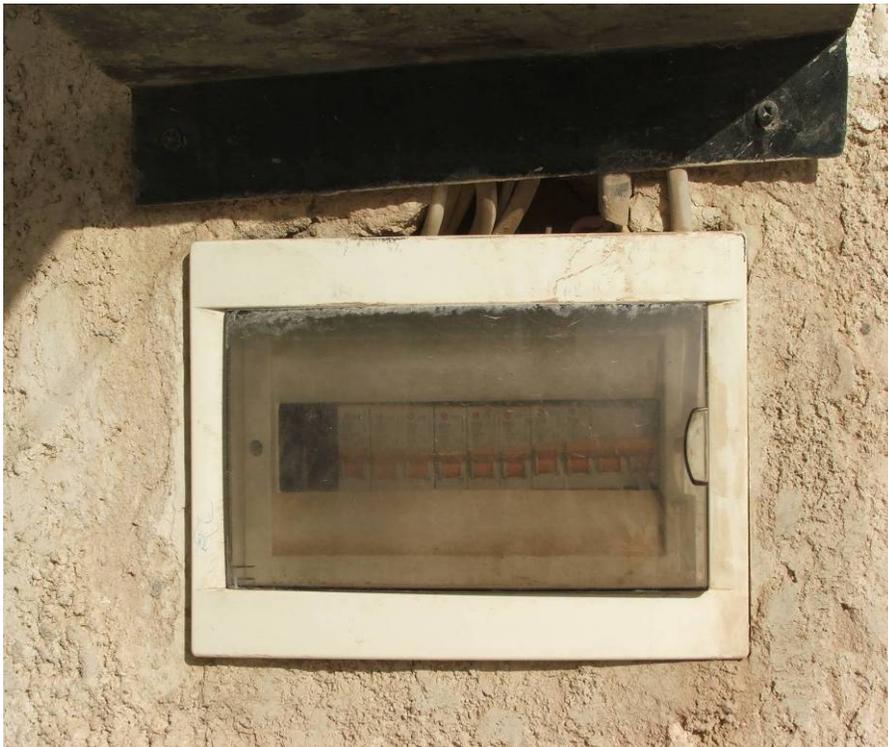
Site Photo 32. Weather exposed circuit breaker box.

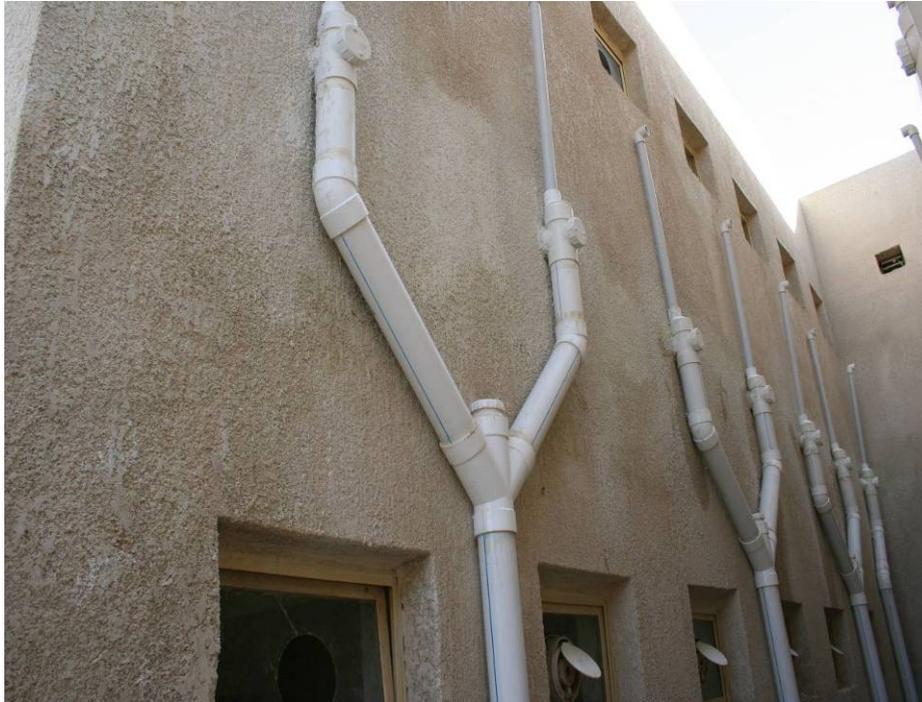
Site Photo 33. Reworked drain lines with upgraded material and improved “Y” design.

recommendation to implement an effective deficiency tracking system or improve related QM procedures. In addition, we verified that the contractor used better materials and an improved drain pipe design when correcting the aforementioned leaks in dormitories D1 and D4 (Site Photo 33).
