ERBIL MATERNITY AND PEDIATRIC
HOSPITAL
ERBIL, IRAQ

SUSTAINMENT ASSESSMENT

SIGIR PA-06-094
APRIL 19, 2007

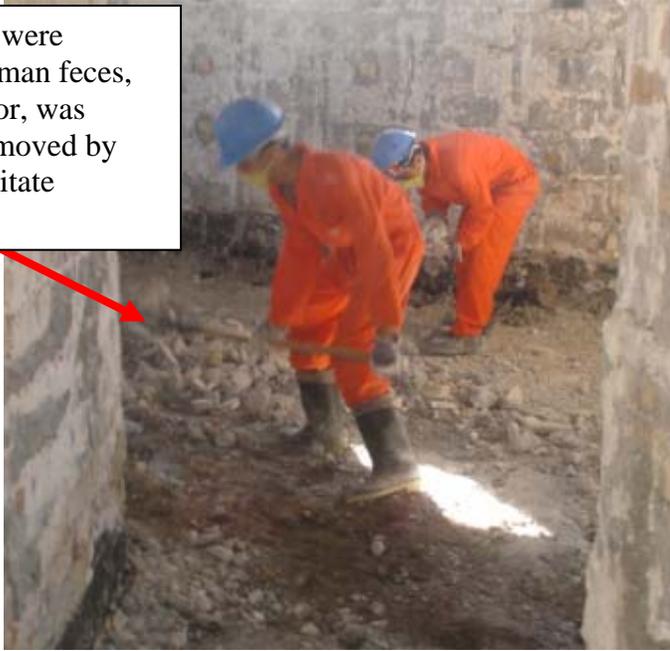
External toilets were plugged and human feces, piled on the floor, was scooped and removed by workers to facilitate renovation.

Site Photo 1. External toilet prior to renovation. (USACE photo taken 18 June 2006)

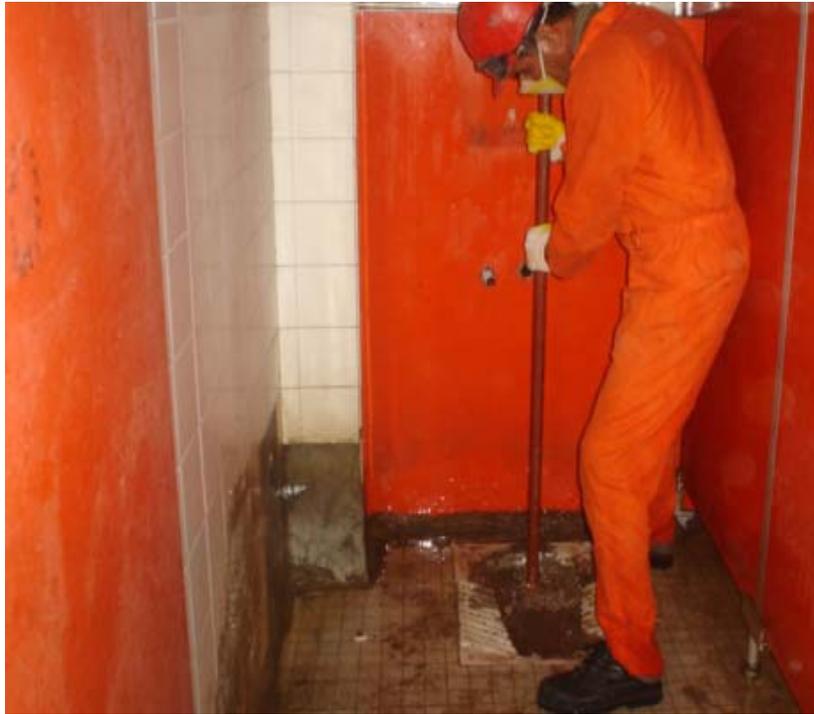
Site Photo 3. Water closet/toilet prior to renovation. (USACE photo taken 11 August 2005)

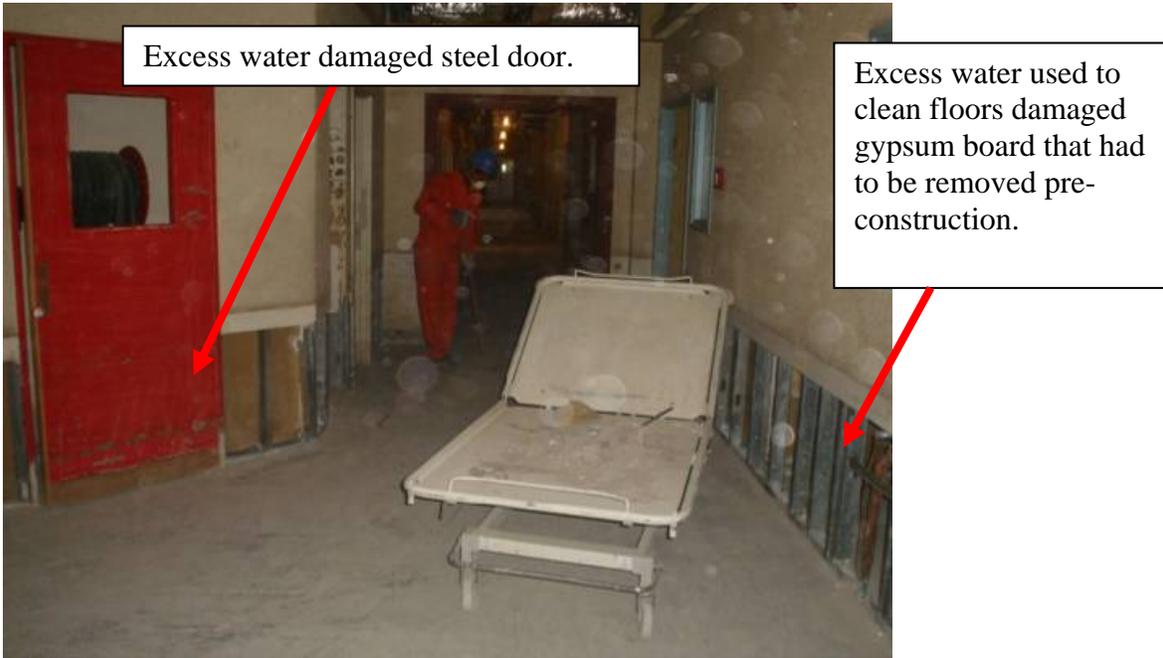
Site Photo 5. Hallway prior to renovation. (USACE photo taken 18 June 2005)

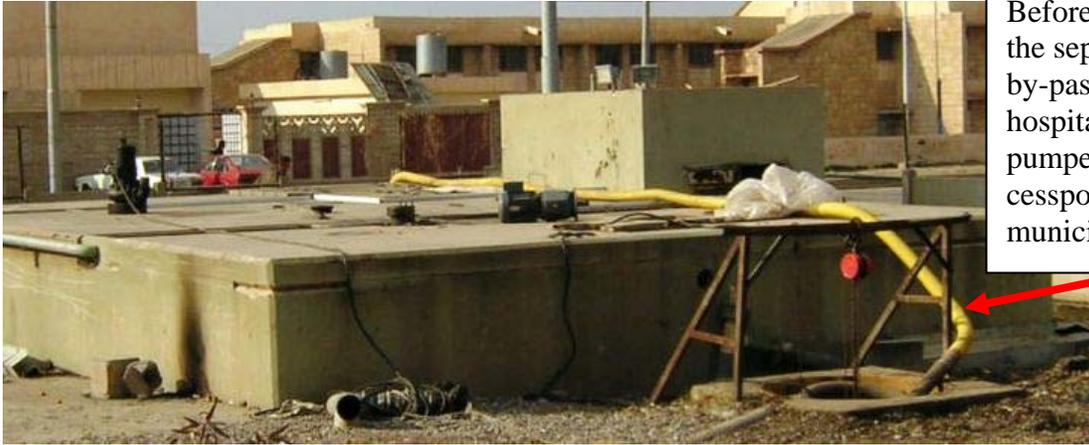
Before renovation, the septic tank was by-passed and hospital sewage was pumped from the cesspool to the municipal system.

Site Photo 7. Plugged septic tank prior to renovation. (USACE photo taken 4 Jan 2005)

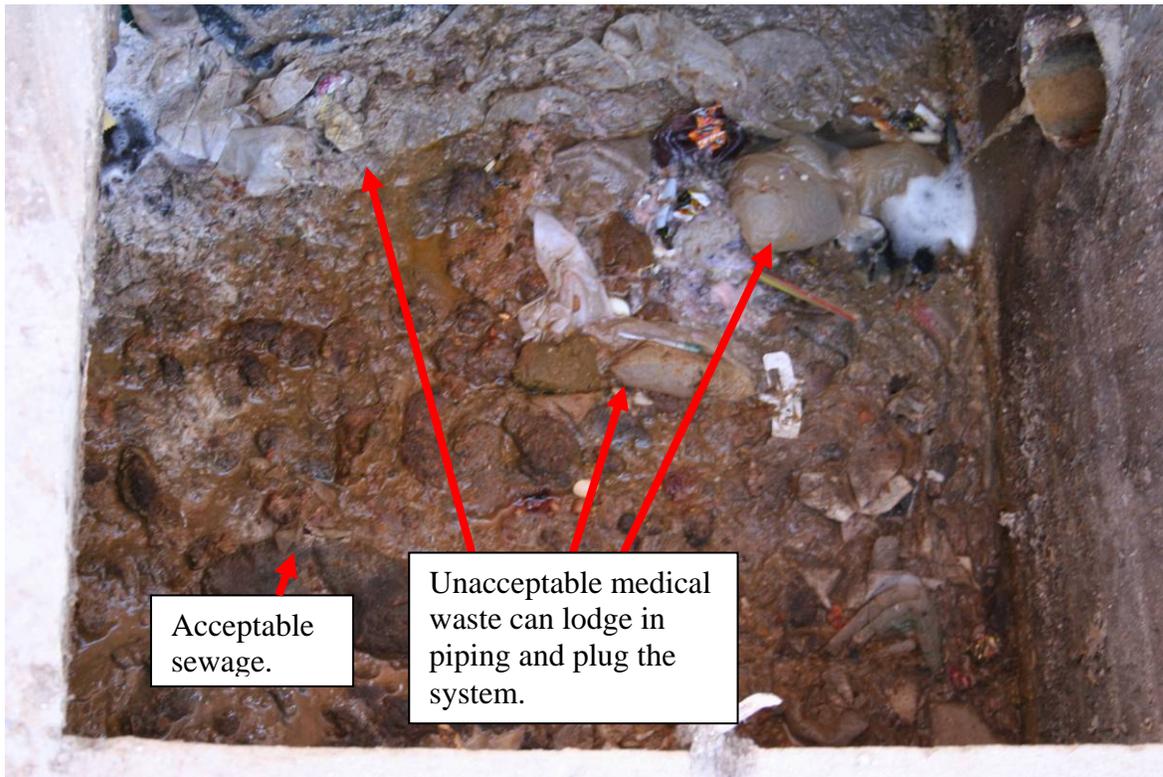
SIGIR inspectors were told by the Minister of Health (MoH), Kurdistan – Iraq and the RE that the sewer system clogged occasionally after the facility was rehabilitated and turned over to Iraqi authorities. When this occurred, grey and waste water² generated inside the hospital did not drain, but instead backed up into sections of the hospital, causing health concerns.

While SIGIR inspectors cannot be certain of the primary cause of such back ups, they did not find this was likely due to inadequate design or insufficient renovation work. Instead, they found a significant contributing factor, if not the primary cause, to be the hospital staffs' improper disposal of medical waste materials into the drains and sewer system. During the site visit, SIGIR inspectors observed large quantities of medical waste materials in the sewer system's traps, manholes, and in septic tank (Site Photo 8).

Site Photo 8. Medical waste material found in manholes and traps

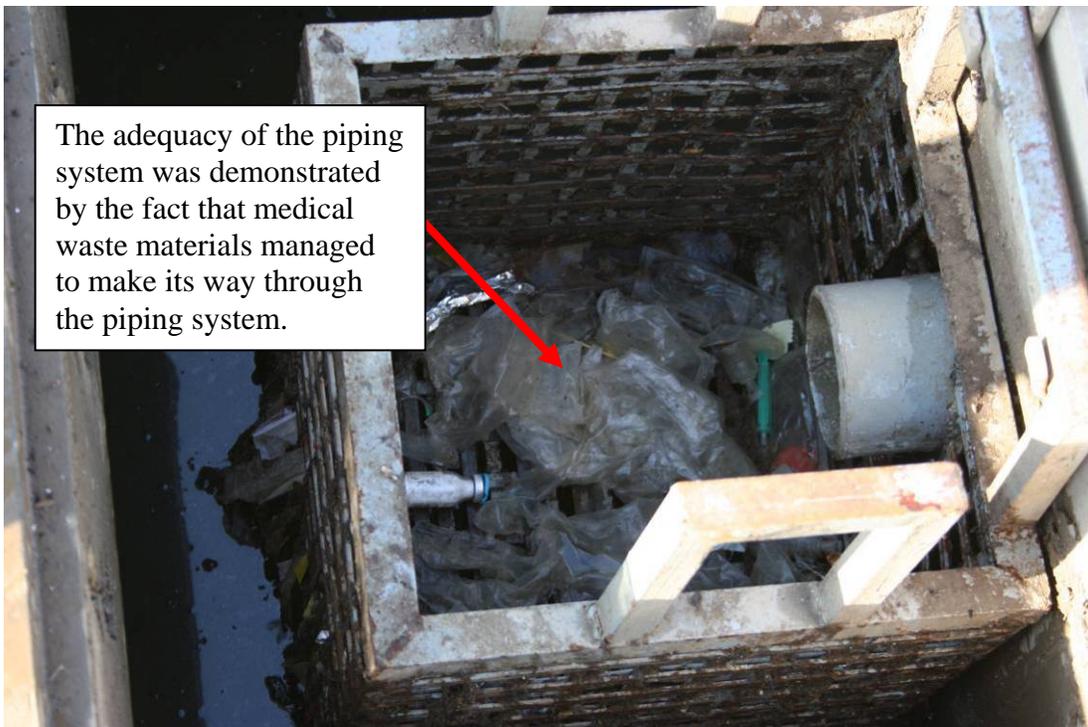
The adequacy of the piping system was demonstrated by the fact that medical waste materials managed to make its way through the piping system.

Site Photo 10. Inlet to septic tank as observed

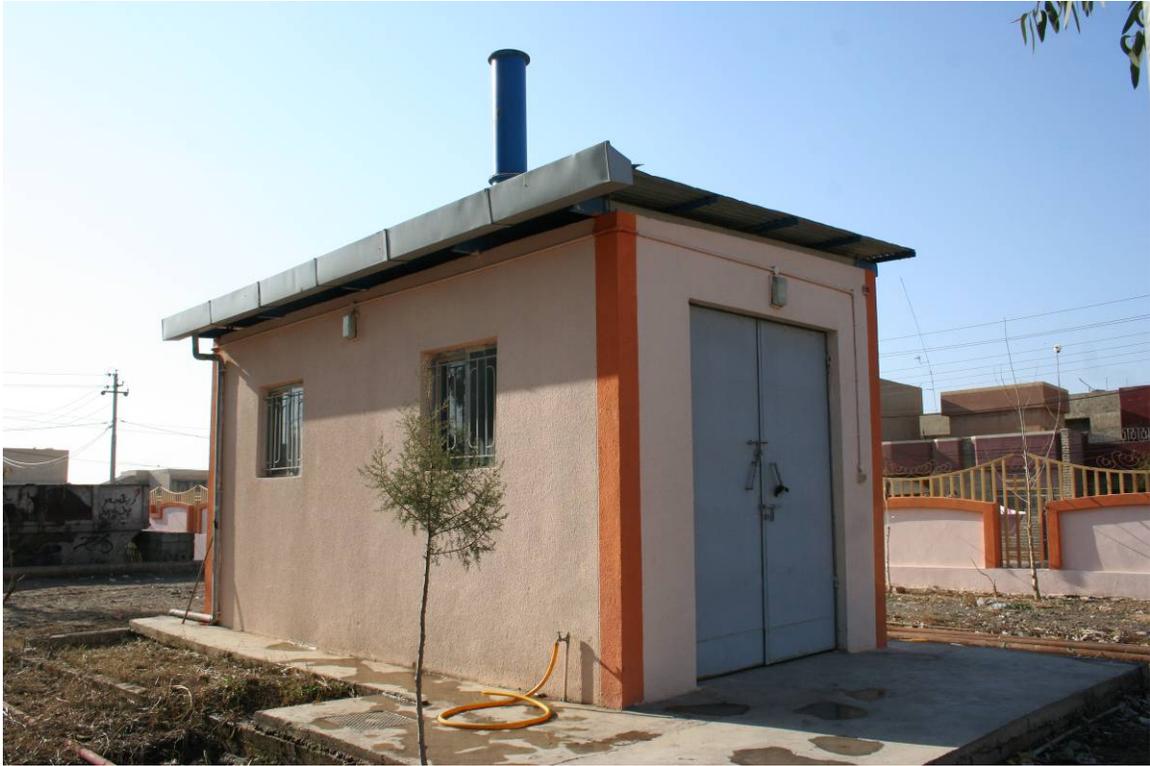
Site Photo 11. Incinerator building

SIGIR inspectors found the incinerator building to be well constructed, but the doors were locked with a conventional padlock. Upon inquiry, the inspectors were told by hospital maintenance and sanitation workers that they did not know where the key was and that the new incinerator was not used to dispose of waste materials since the trained operator(s) were no longer employed at the hospital. The inspectors chose not to question hospital managers about the departure of the trained operators.

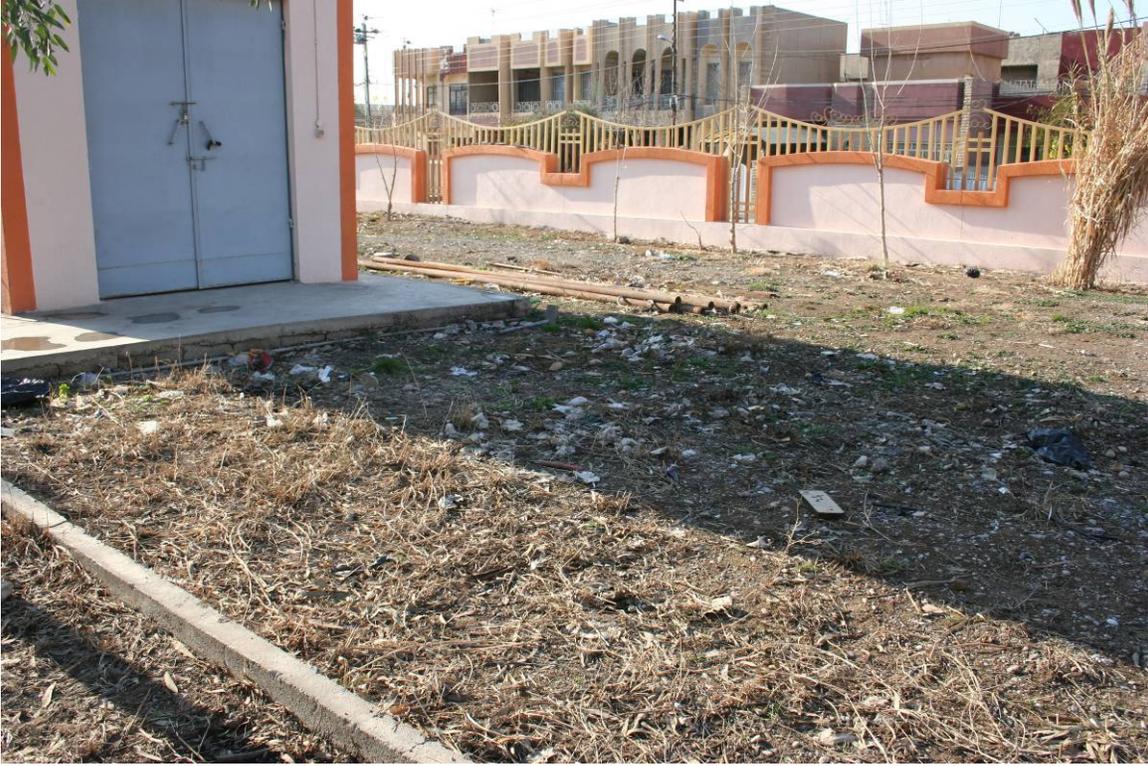
SIGIR found medical waste at various locations at the facility. As previously mentioned, they were found in the sewer system. They were also found on the ground near the door of the incinerator building (Site Photo 12). They were also scattered about the area between the sewer system's cesspool and the rear of the incinerator building (Site Photos 13, 14, and 15).

Site Photo 12. Medical waste materials scattered on the ground area in front of the new incinerator.

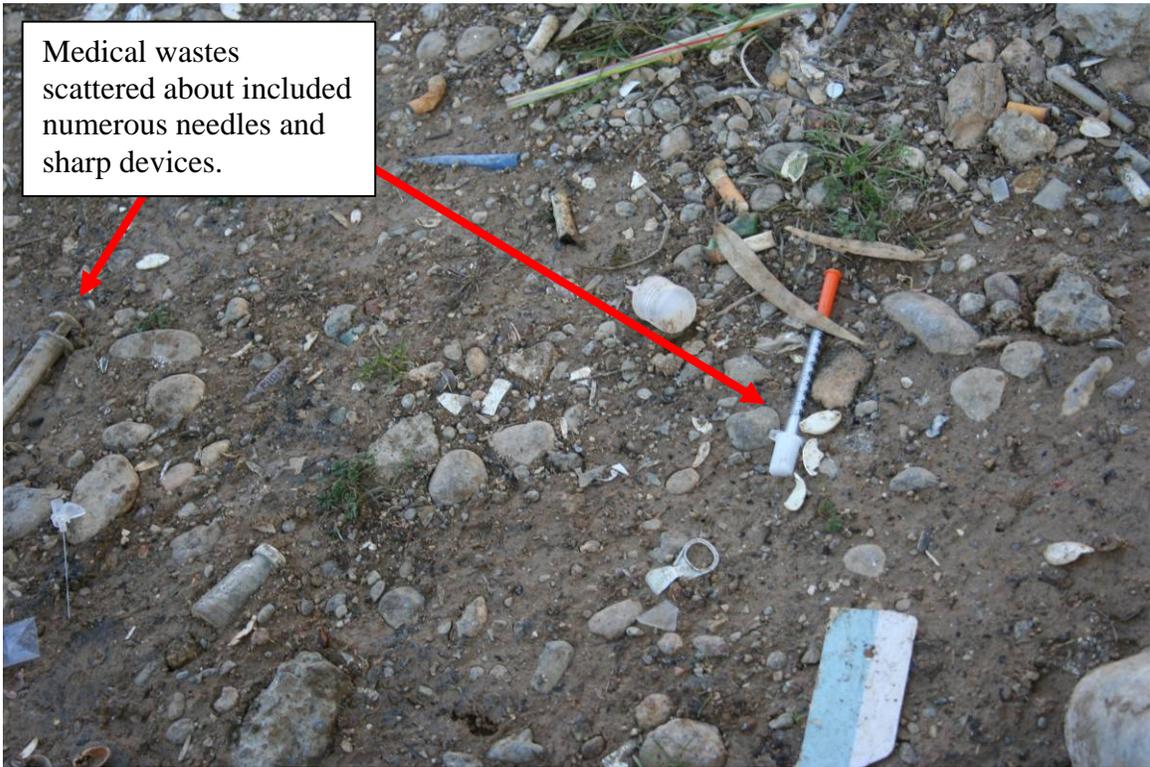
Site Photo 13. Hypodermic needles and other medical waste.

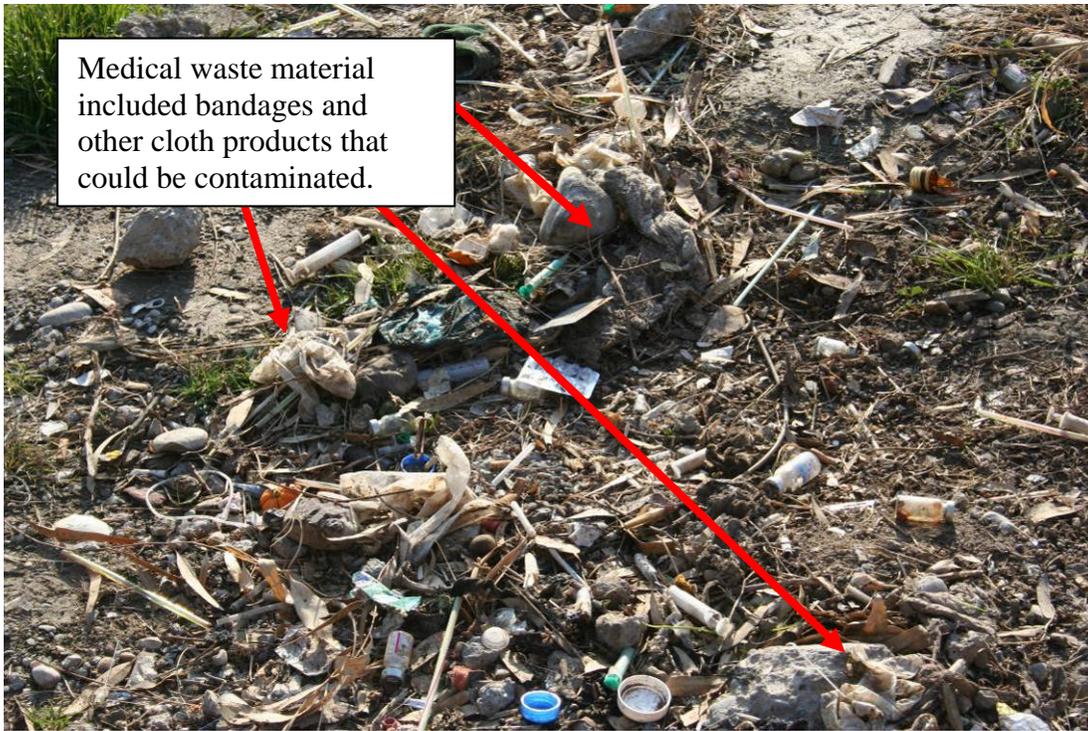
Site Photo 14. Bandages and other medical waste on the ground.

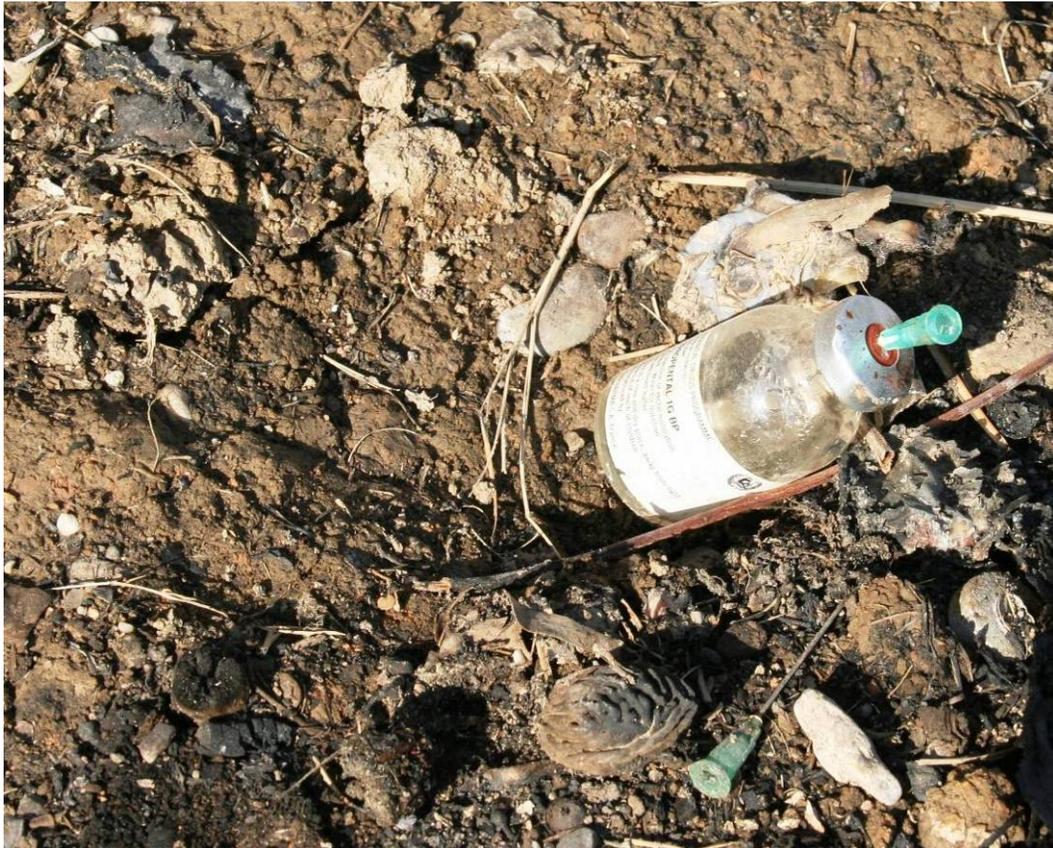
Site Photo 15. Needles and other medical waste.

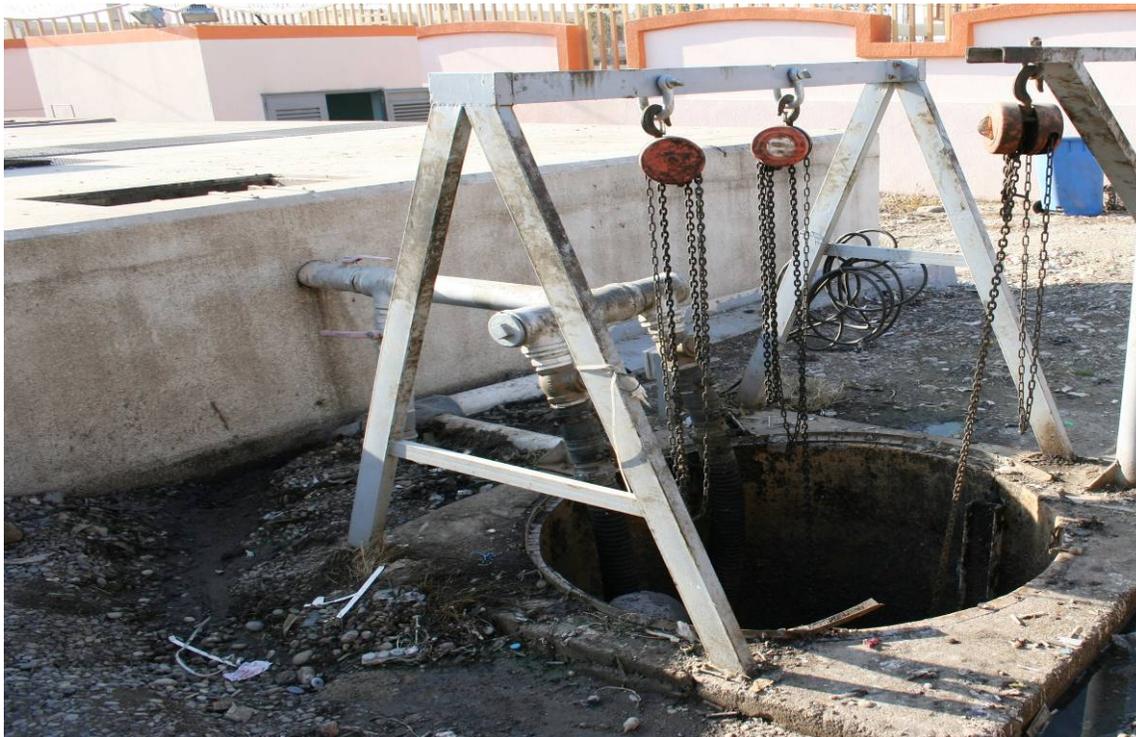
Site Photo 18. During the inspection, the area between the cesspool and septic tank was littered with ineffectively burned medical waste materials.

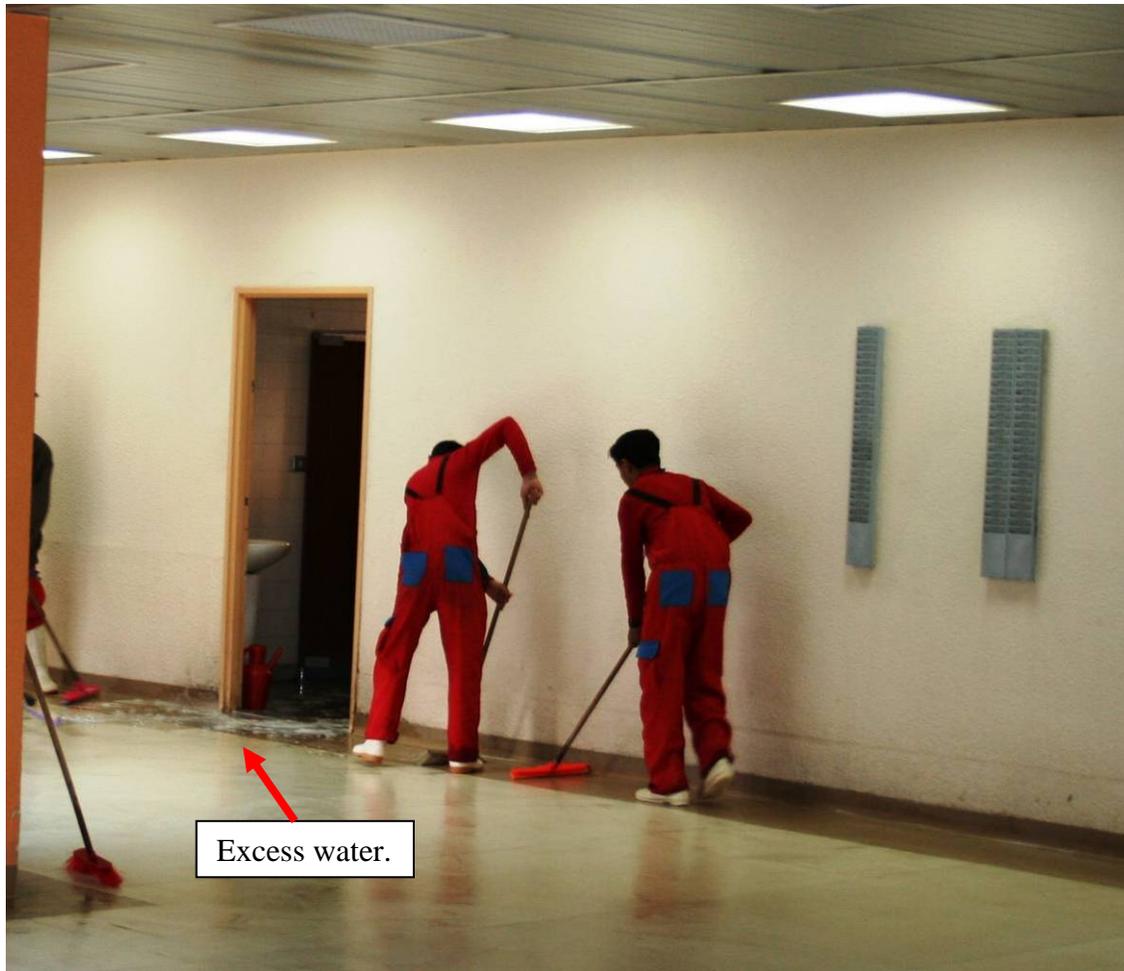
SIGIR inspectors observed cleaning practices that very likely caused and will continue to cause damage to the walls, floors and the basic structure of the facility. Cleaning crews were observed cleaning the lower and upper story hallways with too much water (Site Photo 19).

Site Photo 19. Cleaning crew workers used too much water to clean floors.

According to the USACE RE, this practice has caused water to leak or migrate from the hallways and bathrooms to other places in the facility. It is reasonable to conclude that contaminated water from an upper story hallway or bathroom could migrate to a first floor wall or leak directly through the ceiling. In addition to leading to damage of the walls and floors, the water could spread contaminants. Site Photos 20 and 21 show the damage caused by water migrating from the upper story to the walls of the lower story. In both photos, potentially harmful mold³ or mildew was visible on the moist drywall. Site Photo 22 shows the room of an expectant mother who had been moved because too much water had migrated from the upper story to her room on the lower story.

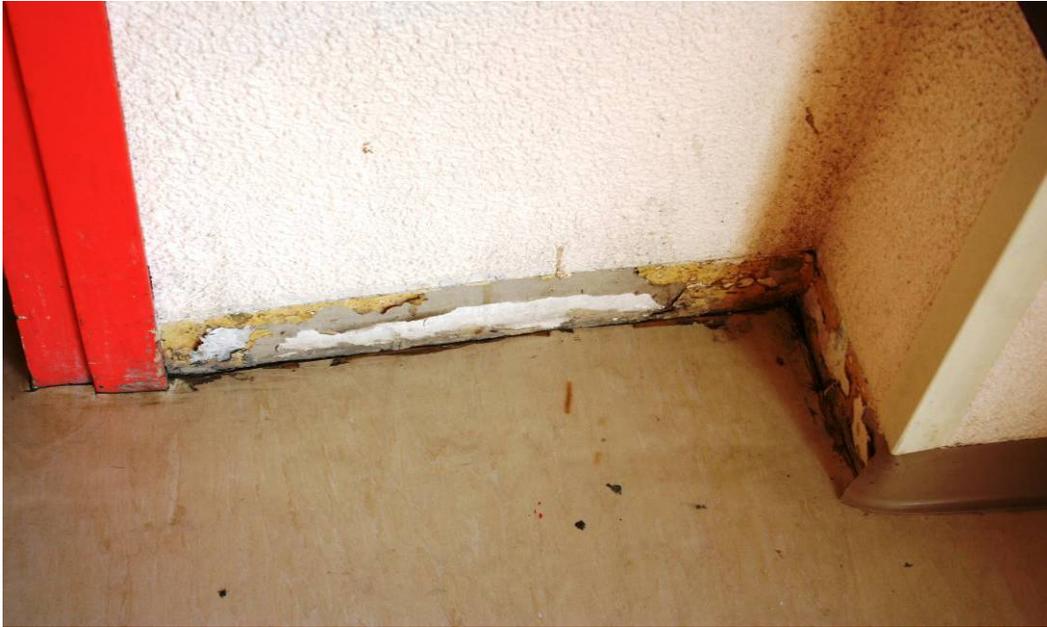
Site Photo 20. Water saturated and damaged wall.

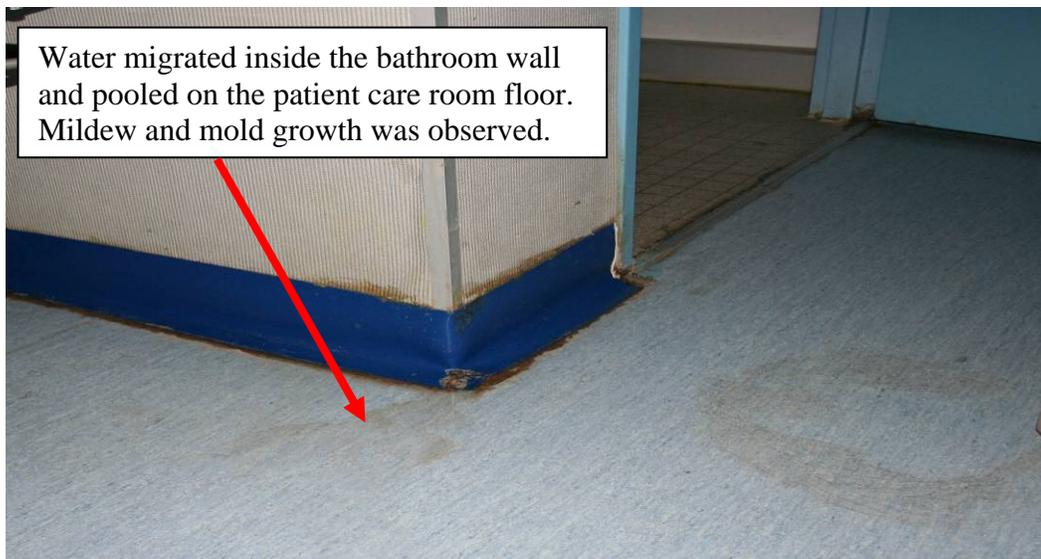
Site Photo 21. Water saturated wall and mildew and mold growth.

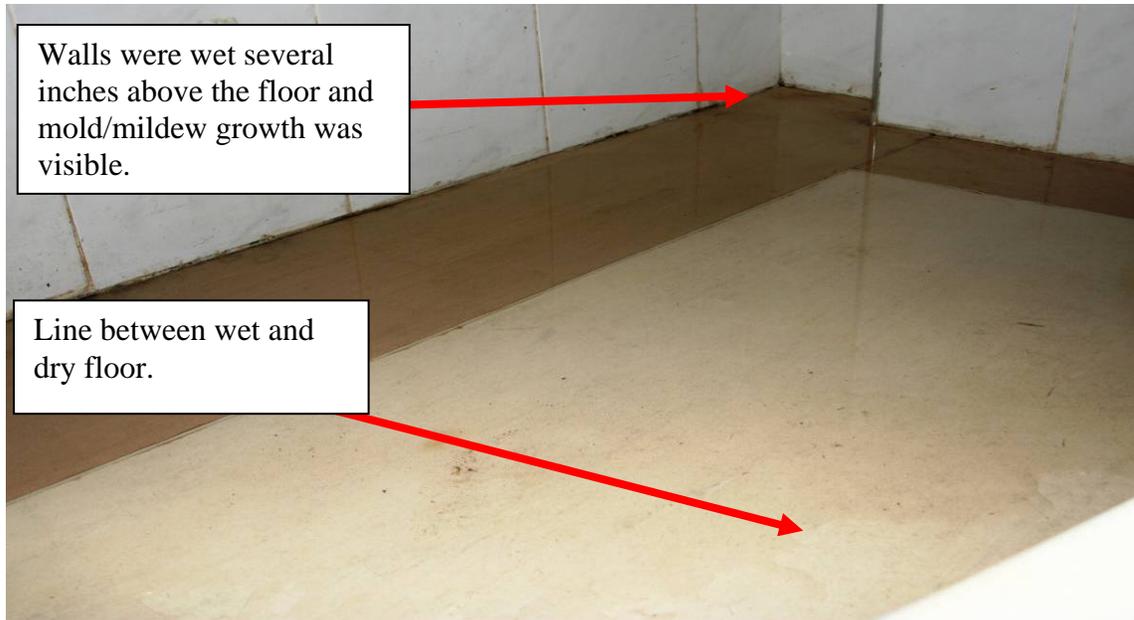
Site Photo 22. Unusable room after water migrated through the walls.

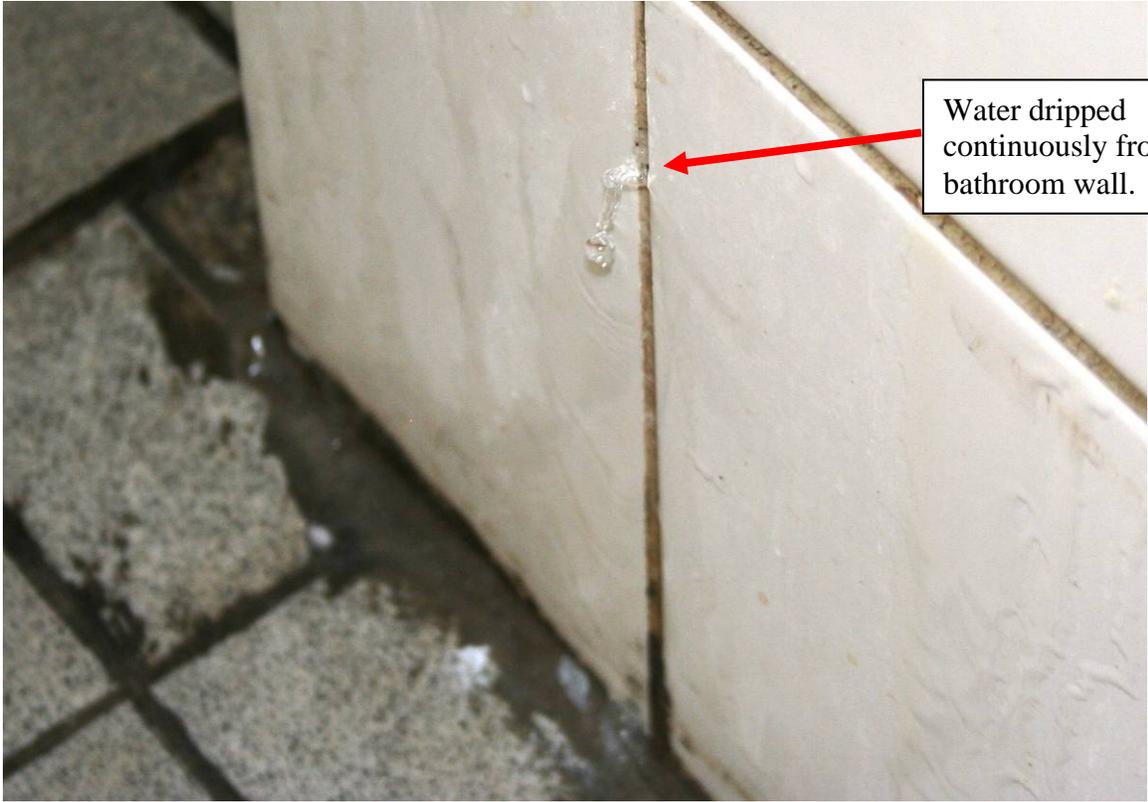
Inspectors also observed an upper floor bathroom where water dripped continuously from the wall (Site Photo 23). The water pooled on the bathroom floor and leaked through the ceiling to a lower story storage room. The damage caused to the ceiling of the storage room is shown in Site Photo 24. While the inspectors could not observe the source of the water, they suspected it was caused by a broken or loose pipe, coupling, or fitting inside the wall, not by workers using too much water to clean floors. The RE advised that the bathroom in question was not included in any renovation work performed by the contractor.

Site Photo 23. Steady dripping of water from a bathroom wall.

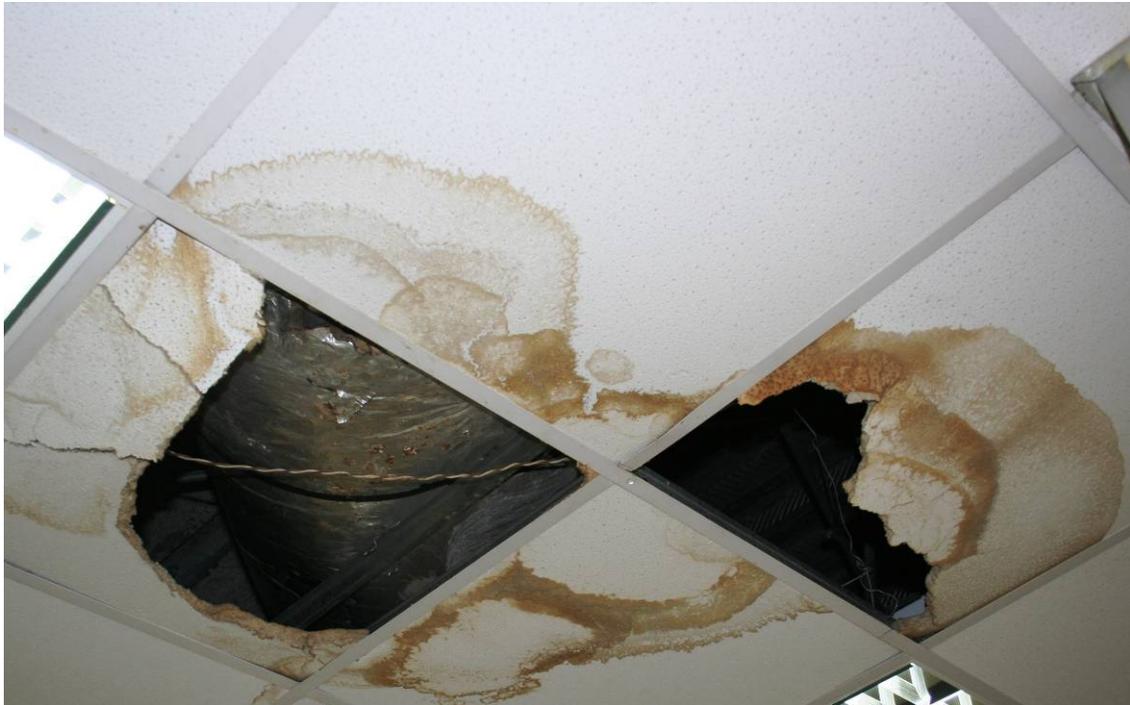
Site Photo 24. Damage from dripping water shown in Site Photo 23.

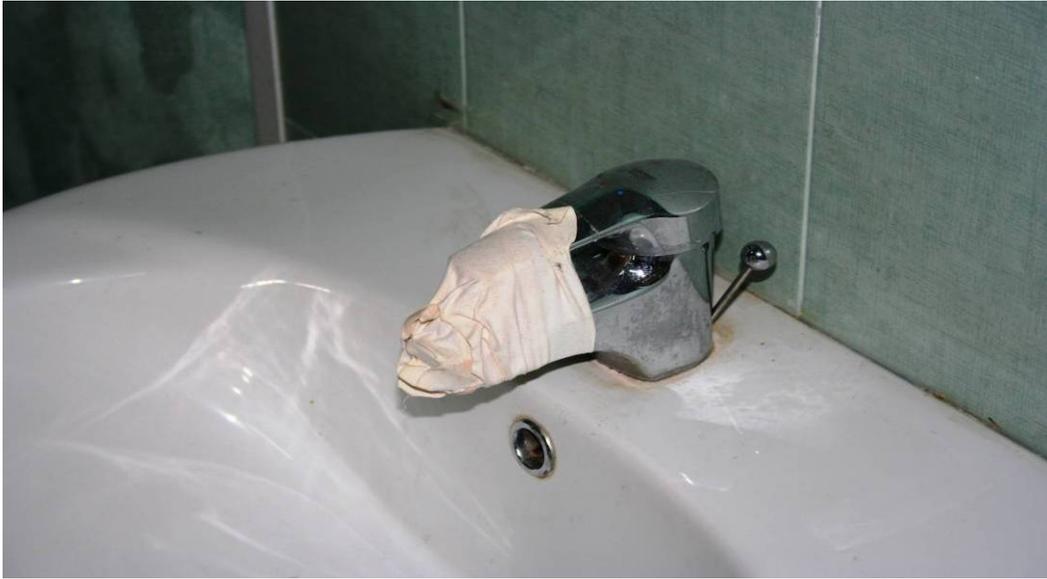
SIGIR inspectors also observed that numerous sinks in patient care rooms were either broken, missing faucet handles or drain pipes, or purposely rendered non-operational. Site Photo 25 shows a sink in a patient care room where the faucet was rendered non-operable, while Site Photo 26 shows a sink, in another patient care room, which was missing the drain pipe/trap assembly. Hospital officials told SIGIR inspectors that parts (drain piping/trap assemblies) were taken to repair sinks elsewhere in the hospital.

Site Photo 25. Some patient care room sinks were unusable.

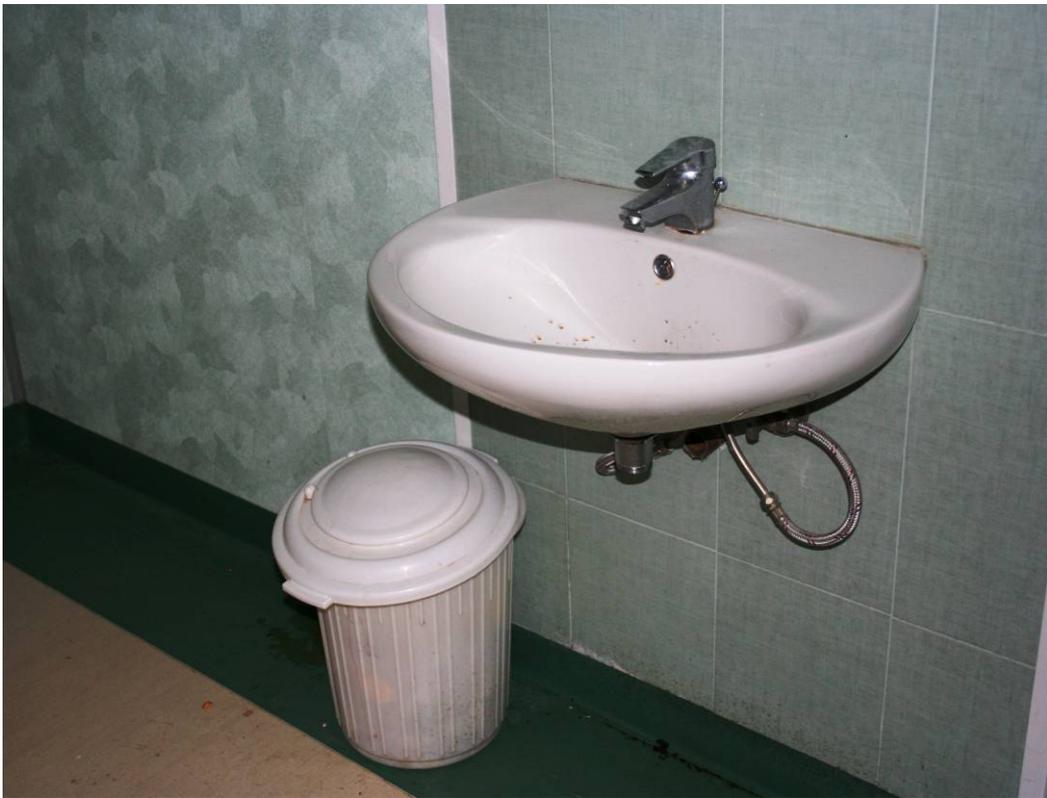
Site Photo 26. Drain pipe/trap was removed from patient care room sink.

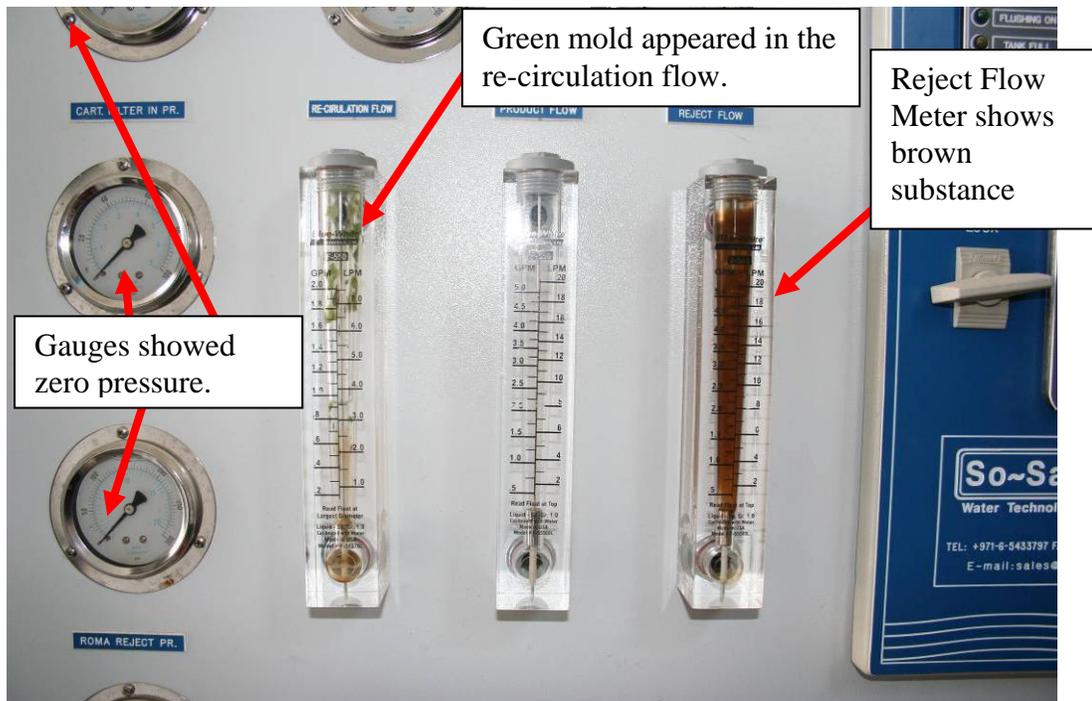
Although turnover documentation indicated that the USACE turned over a fully functional RO system on 1 May 2006, the system was not operational when the SIGIR inspectors conducted their site visit on 19 January 2007. Site Photo 27 shows the front panel of the RO unit with flow meters and pressure gauges. A mold like buildup was observed in the left re-circulation flow meter, while a dark substance stained the reject flow meter and the pressure gauges registered zero pressure.

While SIGIR could not verify when the RO system ceased to function, it appeared that biological contamination fouled RO membranes. It is likely that the RO system's membranes have been permanently damaged based on warnings disclosed in the manufacture's operations and maintenance manual.

The inspectors found that the manufacture's RO preventative maintenance program, if properly followed, would likely have prevented the biological fouling. However, visual evidence indicated that the preventative maintenance program was likely not followed and the RE agreed with this assessment. The inspectors observed new filters piled in the corner of the RO room that could have been used for preventative maintenance.

Site Photo 27. RO Unit's instrument panel.

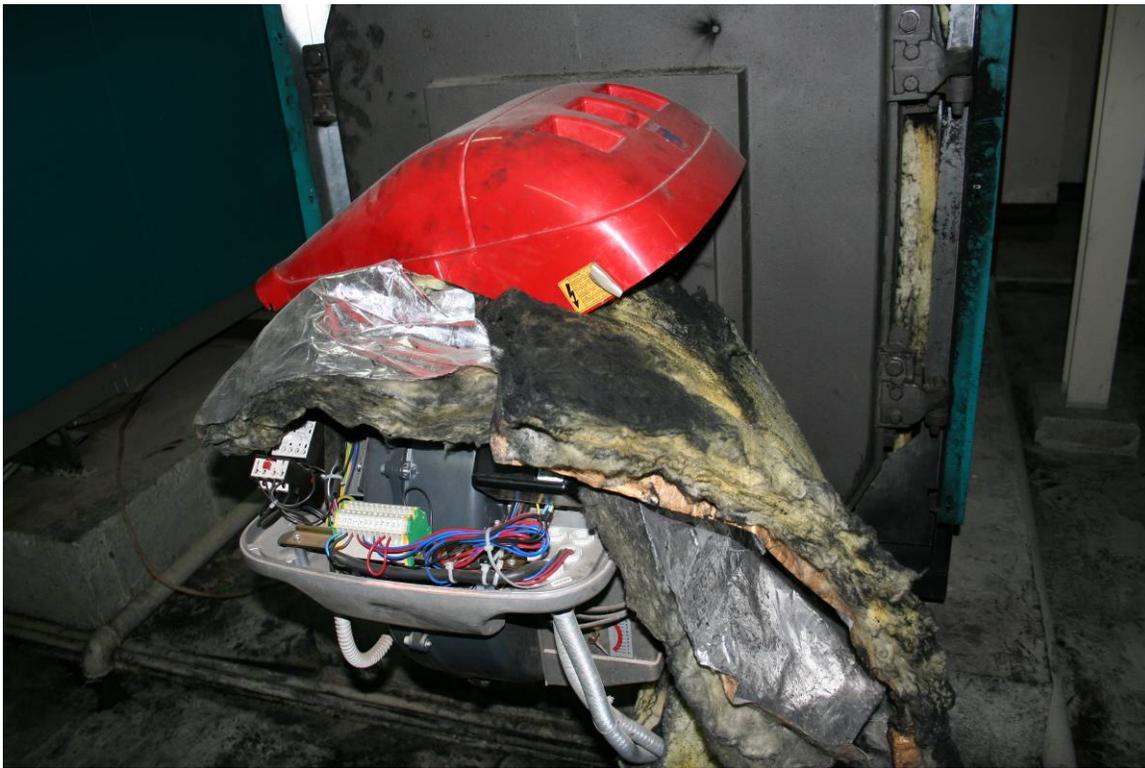
Although all boilers were operational when commissioned and turned over, one of the boilers was inoperable when SIGIR inspectors visited the site. Hospital personnel told the inspectors that the boiler malfunctioned and has since been used as a parts source to maintain the other boilers. In Site Photo 28 the middle boiler has the cover removed and is coated with a carbon film, possibly caused by a fire. Only one boiler was operating at the time of the SIGIR site visit.

Site Photo 28. One of the three boilers was cannibalized for parts.

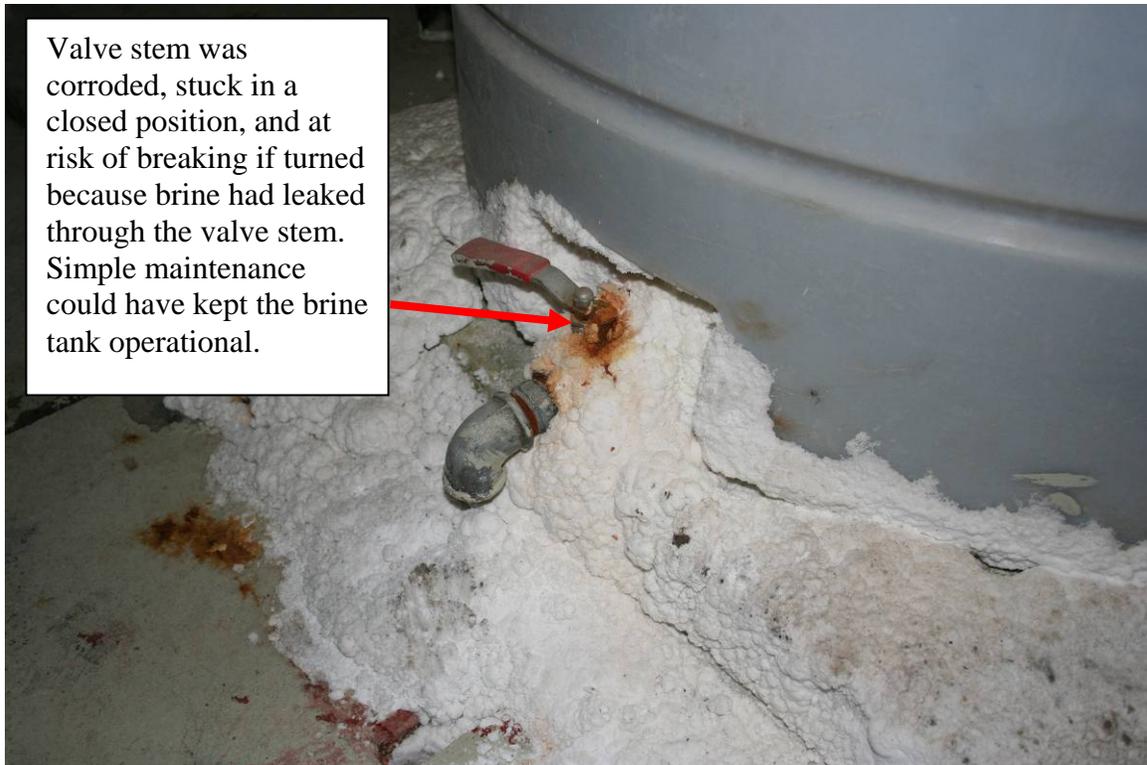
At the time of inspection, the water softener system appeared not to have been operating for an extended period of time. The tanks contained thick discolored brine that had a pungent odor. Inspectors observed a buildup of salt around the brine tank drain valve. Site Photo 30 shows dried brine around a tank. The salt encircled the base of the tank and encased the drain pipes in a thick mass of salt. Corrosion (rust) coated the valve stem and the tank's drain valve. Oxidation, due to the salt, deteriorated the valve to the degree that serviceability appeared questionable at the time of inspection. If turned, it appeared that the valve's stem could have broken off.

The buildup at the base of the tank appeared thick and formed a solid structure. This suggested a low water flow (a leak) over a considerable time. The salt formation suggested water evaporation as the primary reason for the buildup. Additionally, the volume of salt in the relatively small surface area suggests that a large amount of salt and water had leaked and dried.

The RE and inspectors agreed that more than likely ineffective maintenance practices caused the breakdown of the water softener system. The RE also agreed that water softener operations and maintenance is not complex when compared to the heating and cooling system as a whole. However, the lack of a functioning water softener system could lead to future large-scale problems in the heating and cooling system.

Site Photo 30. Dried salt was layered around the base of the brine tank.

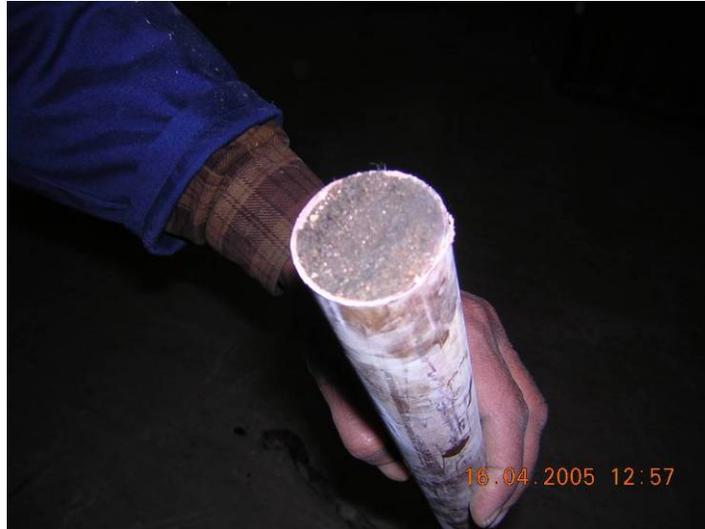
SIGIR found evidence of past maintenance problems with the HVAC system at the facility prior to the U.S. funded reconstruction project. Specifically, particles clogged the HVAC system before construction. A clog made up of settled particles that closed off a chiller water line is shown in Site Photo 31.

Site Photo 31. Plugged chiller water line before renovation. (USACE photo)

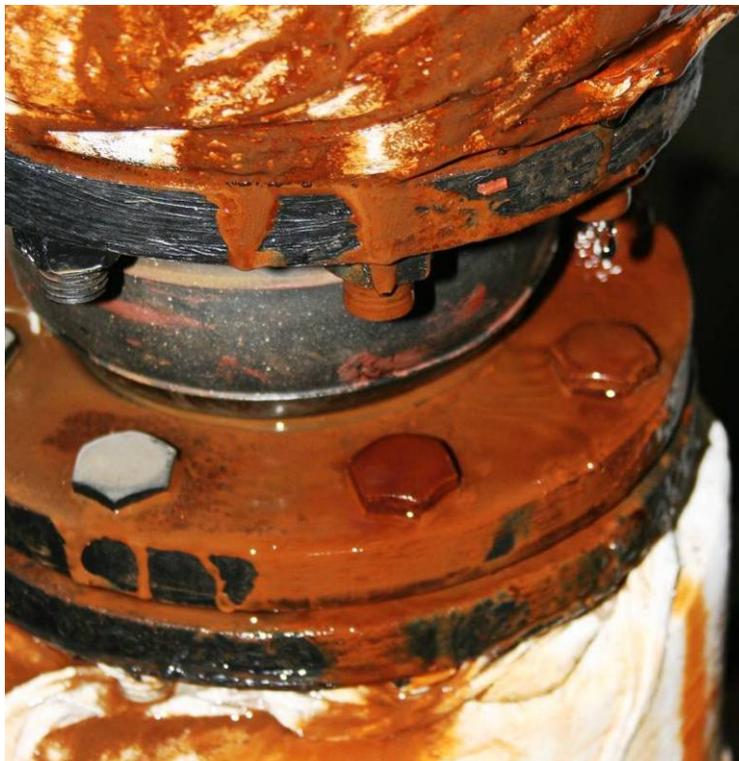
A flushed system with clean filters could prevent future failures, overheating and boiler cracking caused by plugging, and deterioration of materials. Inspectors observed rust and a water leak in piping above the hot water pump. In Site Photo 32, a water leak developed layers of rust across the surface of hot water piping. The rusty water from the leak indicates a very strong likelihood of a rust and particulate buildup forming inside the new piping. Considering the hospital's history of the clogged HVAC pipe pre-renovation and other maintenance practices, it is likely that without a positive change in operations and maintenance practices, degradation of the HVAC will result.

Site Photo 32. Evidence that rust contaminated water has leaked from a hot water line flange for an extended period of time.

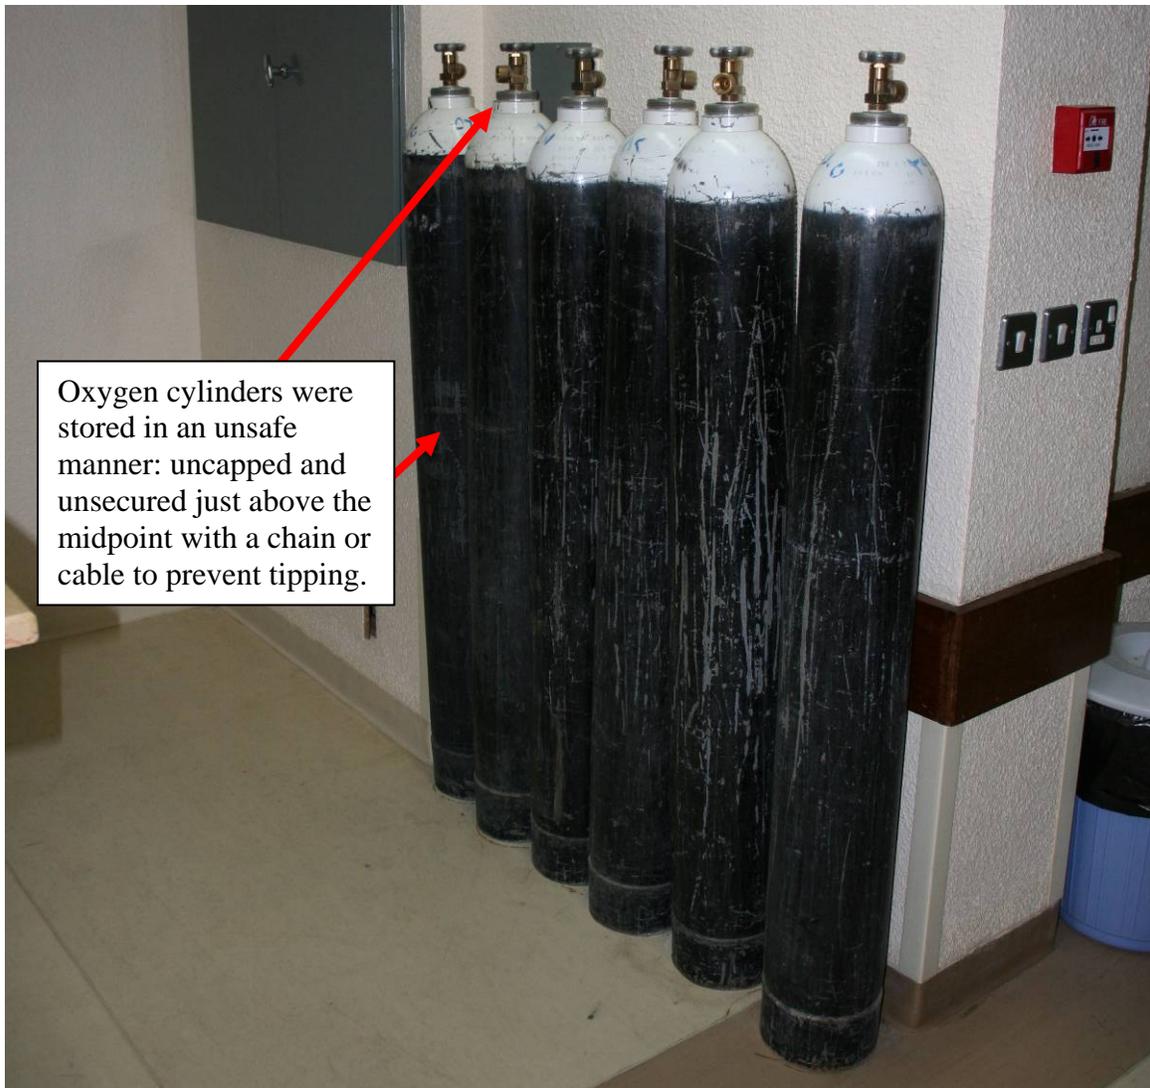
The inspectors also observed that the cylinders were stored in an unsafe manner. Specifically, valves were not protected with a cap, a chain or cable placed just above the midpoint was not used to secure cylinders in an upright position, and the cylinders were not stored in a protected area away from hallway traffic.

Site Photo 34. O2 bottles were stored in the hallway.
