ERBIL MATERNITY AND PEDIATRIC
HOSPITAL
ERBIL, IRAQ

SUSTAINMENT ASSESSMENT

SIGIR PA-06-094
APRIL 19, 2007

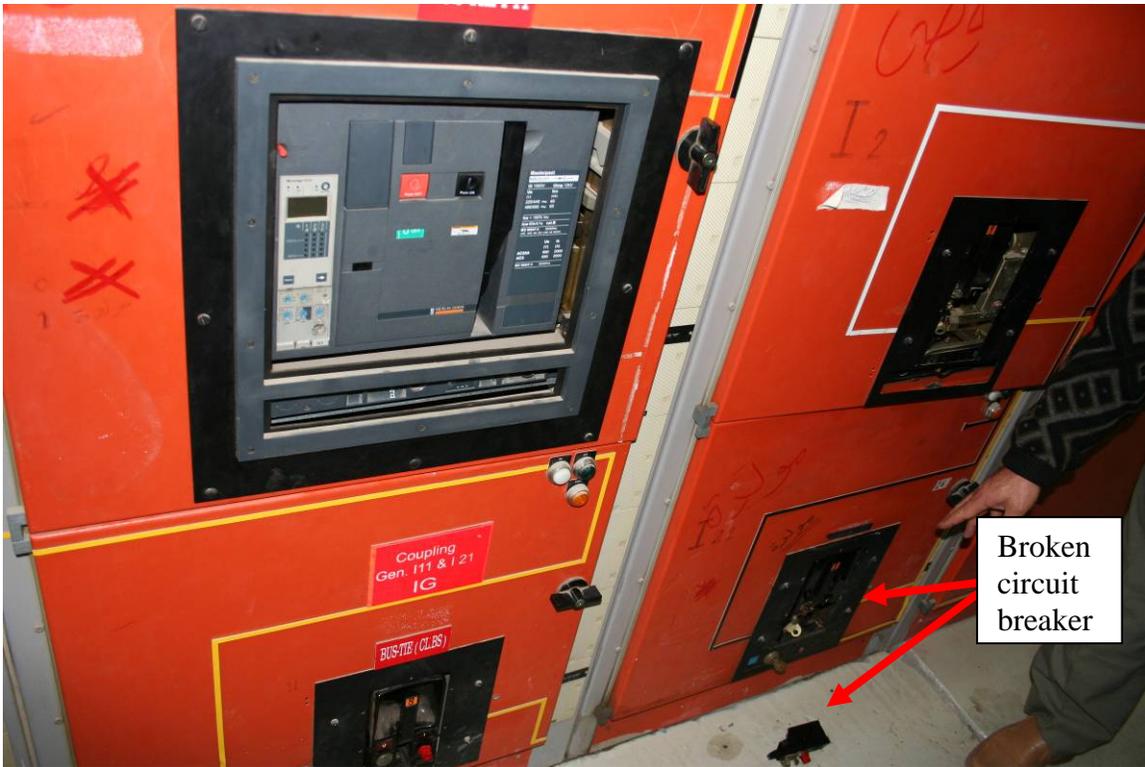
Switchgears link the power system and generators. Site Photo 37 shows a broken breaker that prevents the switchgear from automatically operating as designed. In the photo, a piece of the broken switchgear lays on the floor while the circuit remained in the open or off position. Although hospital personnel pointed out the broken breaker to inspectors and the switchgears remained under warranty, hospital maintenance workers told SIGIR inspectors and the RE that they had not initiated any efforts to secure repair or replacement via the manufacturer.

Site Photo 37. Broken circuit breaker that disabled switch gear equipment.
