ERBIL MATERNITY AND PEDIATRIC
HOSPITAL
ERBIL, IRAQ

SUSTAINMENT ASSESSMENT

SIGIR PA-06-094
APRIL 19, 2007

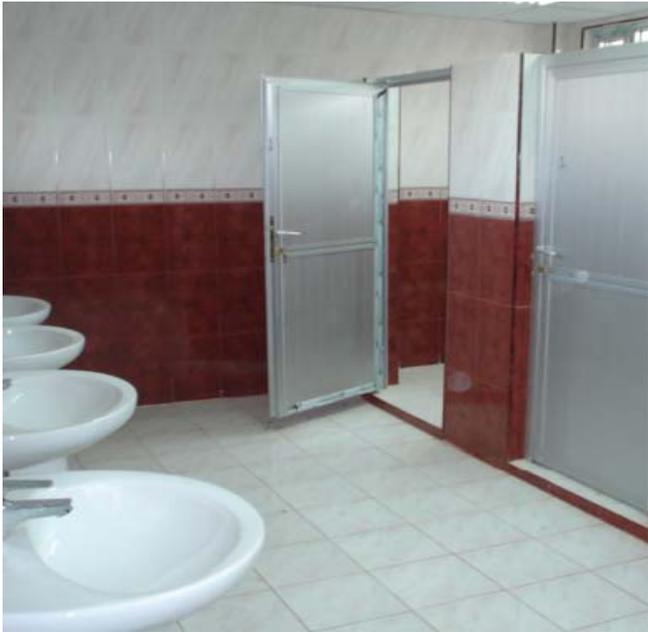
During interviews and reviews of records and photographs, SIGIR found that substantive improvements were made to the facility during the rehabilitation (Site Photos 2, 4, and 6). These improvements are addressed later in this report, but are introduced here for comparison purposes.

Site Photo 2. External toilet following renovation. (USACE photo taken 18 Jan 2006)

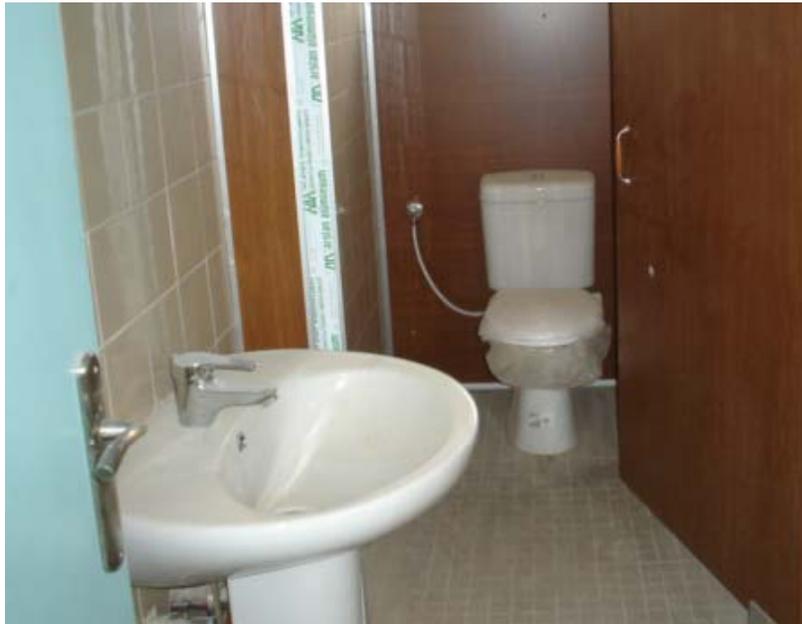
Site Photo 4. Toilet with sink following renovation. (USACE photo taken 8 Jan 2006)

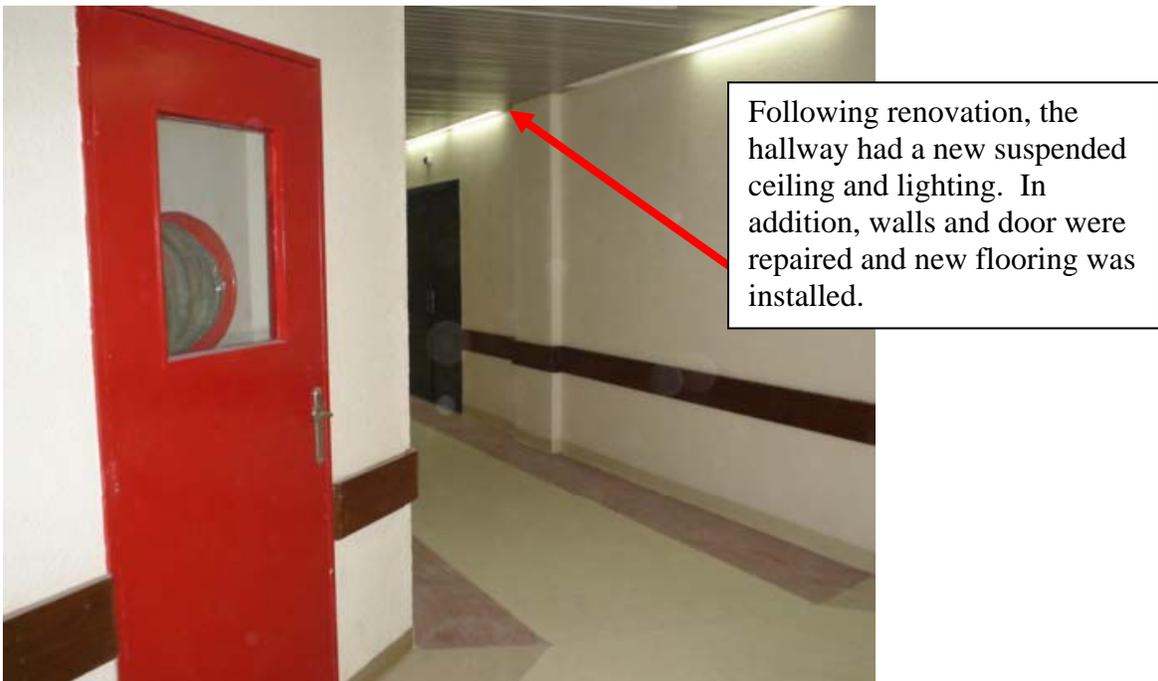
Site Photo 6. Hallway following renovation. (USACE photo taken 8 Jan 2006)

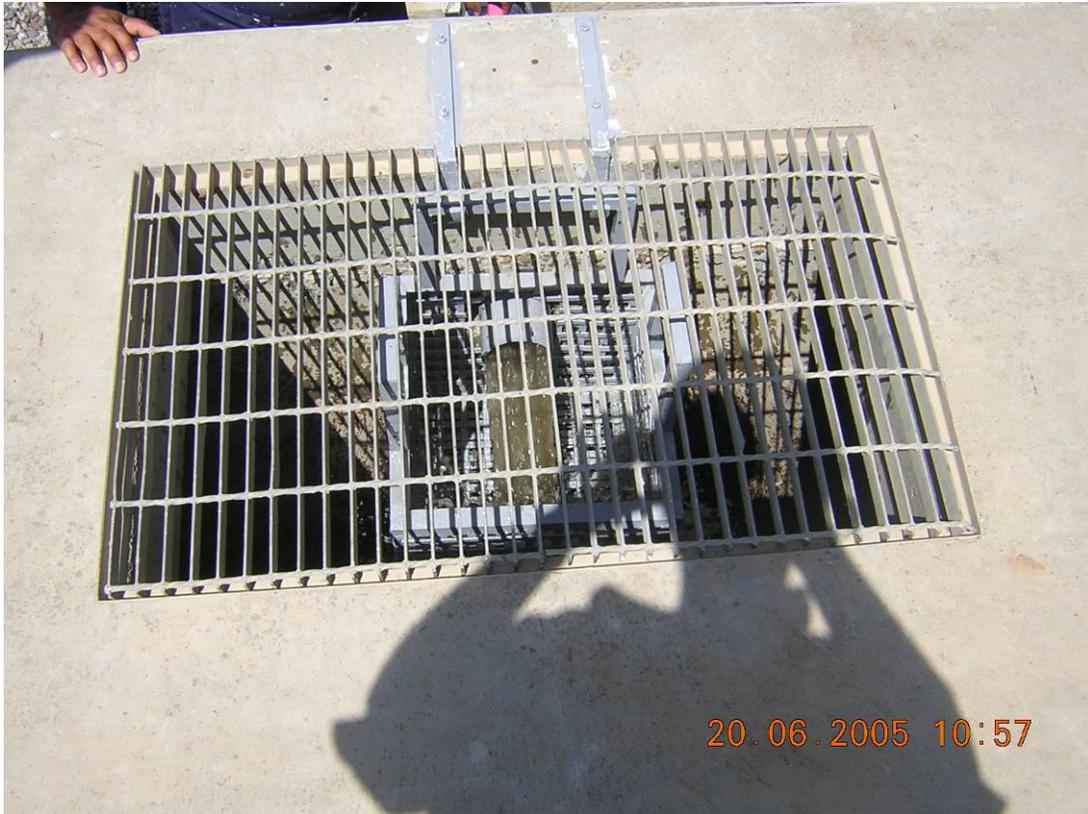
A comparison of the septic tank before and after turnover to Iraqi authorities is presented below. The USACE photo (Site Photo 9) was taken during rehabilitation work. The SIGIR photo (Site Photo 10) was taken on 19 January 2006 during the site inspection, well after the project was turned over to Iraqi authorities.

Site Photo 9. Inlet to septic tank was clean during commissioning. (USACE photo)

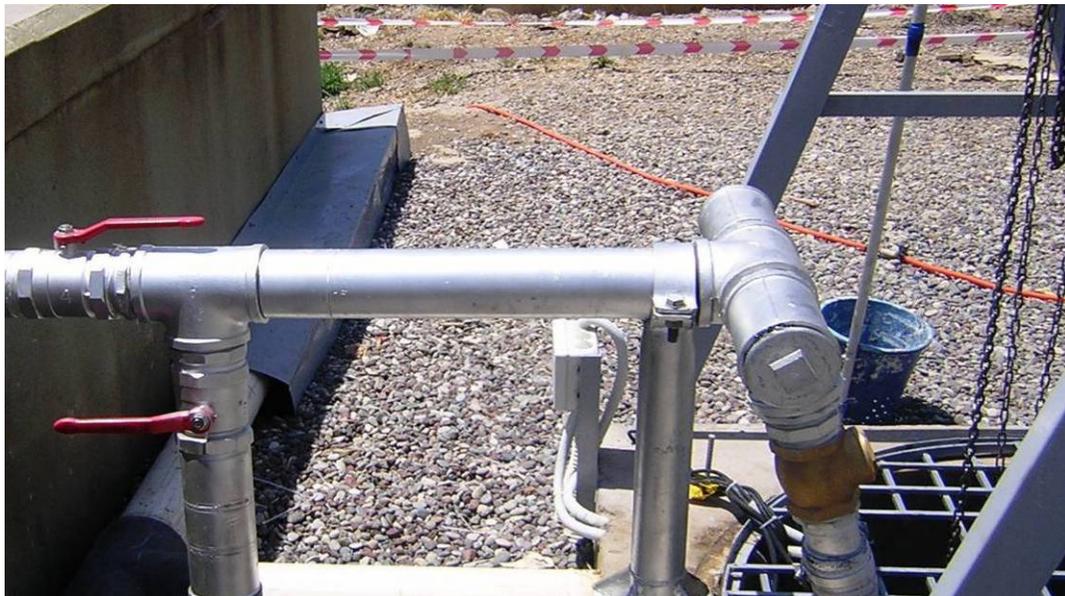
USACE site photos taken immediately after project work was completed show that the areas were clear of all medical waste materials and in good condition (Site Photos 16 and 17). This same area was littered with medical waste materials when observed by SIGIR inspectors on 19 January 2006 (Site Photo 18). The medical waste materials observed included medical gloves, needle sharps, syringes, ampules, bandages, and other types of medical supplies.

Site Photo 17. Immediately following renovation, the area adjacent to the cesspool was clean. (USACE photo)
